Technical Memorandum - Final

*Bluewater Park Wellfield Assessment (Phase 2 and Phase 3)
Mutiny Lane, Bowen Island, BC
Project No. VAN-00254172-A0
December 5, 2019*

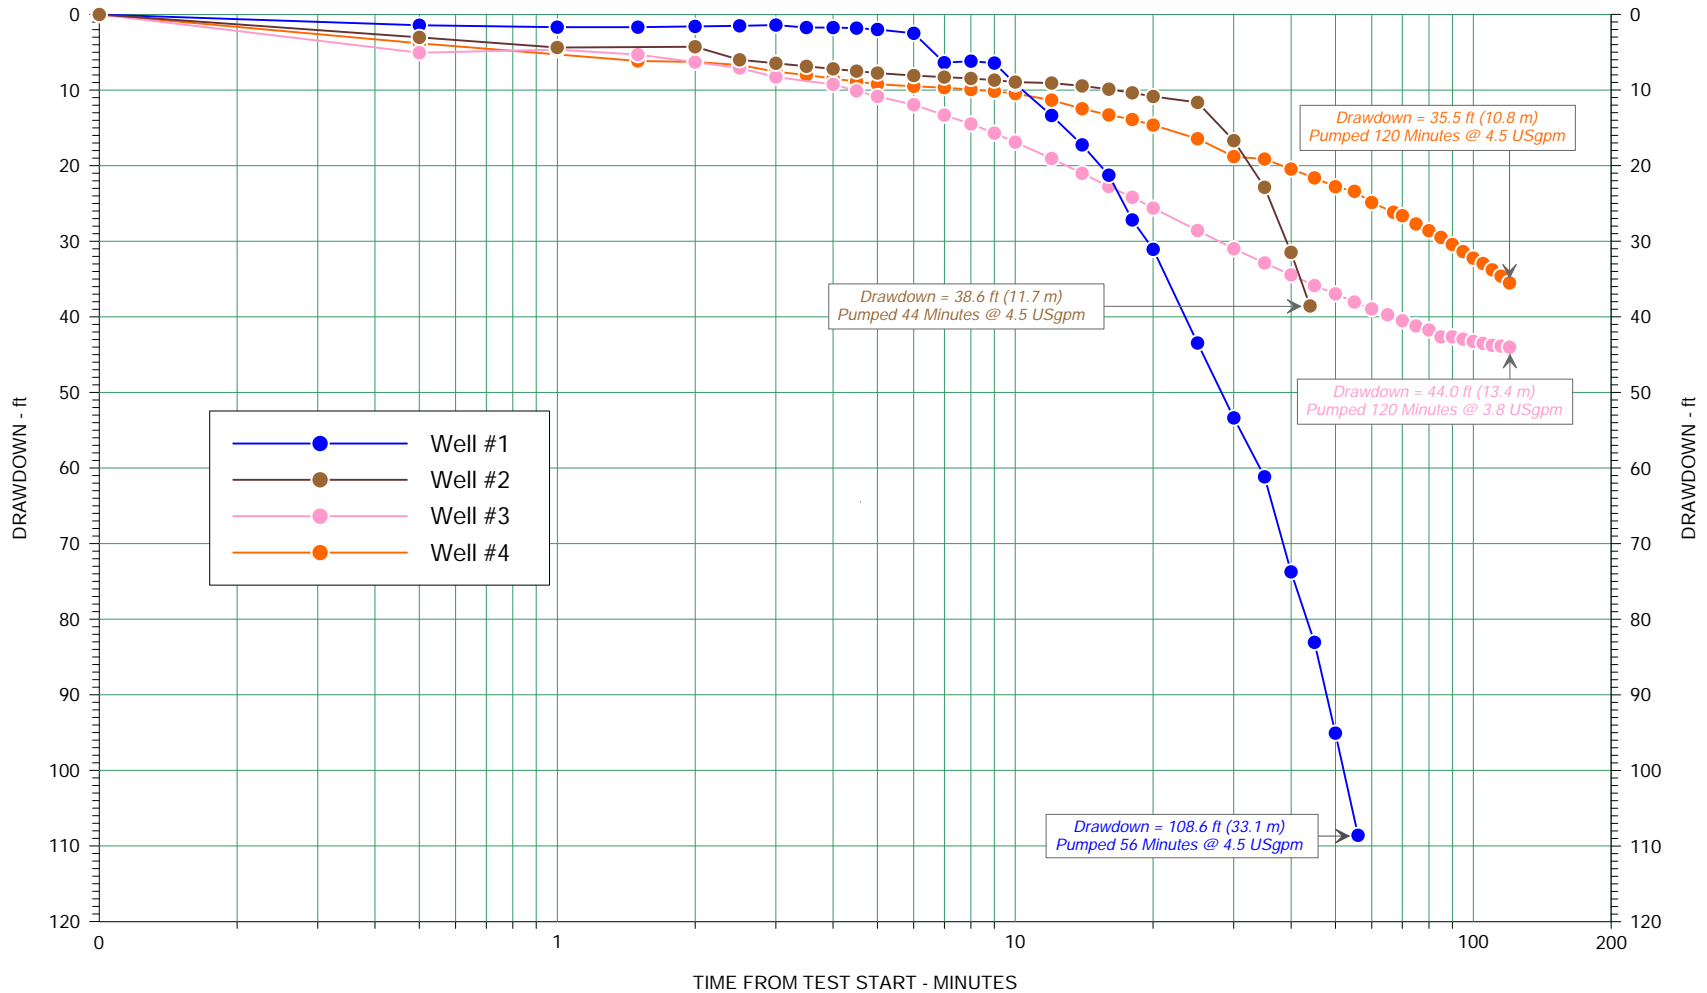
PUMPING TESTS IN BLUEWATER PARK WELLS Drawdown Response Monitoring (Phase 2) July 24-25 and August 23, 2019

Upon completing the submersible camera surveys, the pump assemblies were reinstalled to the original depths. Independent short-duration pumping tests were then conducted using a constant pumping rate of 4.5 USgpm¹ selected based on a maximum pump capacity of 5 USgpm. An inline flow meter and valve were temporary installed on each well riser pipe to allow monitoring and control of the applied pumping rate. Precision personnel intermittently obtained manual water level measurements during testing using a graduated electric tape. A graphical summary of the water levels acquired during testing is provided on Figure 1 (Attachment #3).

Testing in Well #1 was completed on July 24, 2019. After 56 minutes of sustained pumping at 4.5 USgpm, the water level drawdown in Well #1 was approximately 108.6 ft (33.1 m) below the pre-test static (i.e., non-pumping) level of 243.0 ft-bg (74.0 m-bg). It was necessary to terminate the pumping test to avoid exposing the Well #1 pump and potentially damaging the motor. Based on the magnitude of the end-of-test drawdown, the applied pumping rate, and the initial static water level, the preliminary yield of Well #1 was estimated to be approximately 2.5 USgpm. For comparative purposes, the original yield of Well #1 was estimated at 10 USgpm to 12 USgpm in 1986.

Testing in Well #2 was completed on August 23, 2019. After 44 minutes of sustained pumping at 4.5 USgpm, the water level drawdown in Well #2 was approximately 38.6 ft (11.7 m) below the pre-test static level of 240.5 ft-bg (73.3 m-bg); accordingly, it was necessary to terminate pumping to avoid exposing the pump and damaging the motor. Based on these results, the preliminary yield of Well #2 was estimated to be approximately 2.0 USgpm as compared to the original yield estimate of 15 USgpm to 20 USgpm in 1986.

Testing in Well #3 was completed on August 23, 2019. After 120 minutes of sustained pumping at 3.8 USgpm, the drawdown in Well #3 was approximately 44.0 ft (13.4 m) below the pre-test level of 178.3 ft-bg (54.3 m-bg). Based on the measured drawdown, the applied pumping rate, and the initial static water level, the preliminary yield of Well #3 was estimated to be approximately 3.4 USgpm. For comparative purposes, the original yield of Well #3 was estimated at 8.0 USgpm in 1991.

Testing in Well #4 was completed on July 25, 2019. After 120 minutes of sustained pumping at 4.5 USgpm, the drawdown in Well #4 was approximately 35.5 ft (10.8 m) below the pre-test water level of 292.8 ft-bg (89.2 m-bg). Based on the measured drawdown, the applied pumping rate, and the initial static water level, the preliminary yield of Well #4 was estimated to be approximately 9.4 USgpm. For comparative purposes, the original yield of Well #4 was estimated at 6.5 USgpm in 1991.

Combined analysis of the Phase 2 pumping test data trends (Figure 1) and the long-duration Phase 3 pumping tests (Figure 3) indicate that the individual yields of Well #1, Well #2 and Well #4 are 46% to 90% less than the values reported at the time of well construction, as summarized in Table 2. The Well #3 yield is relatively unchanged (Table 2).

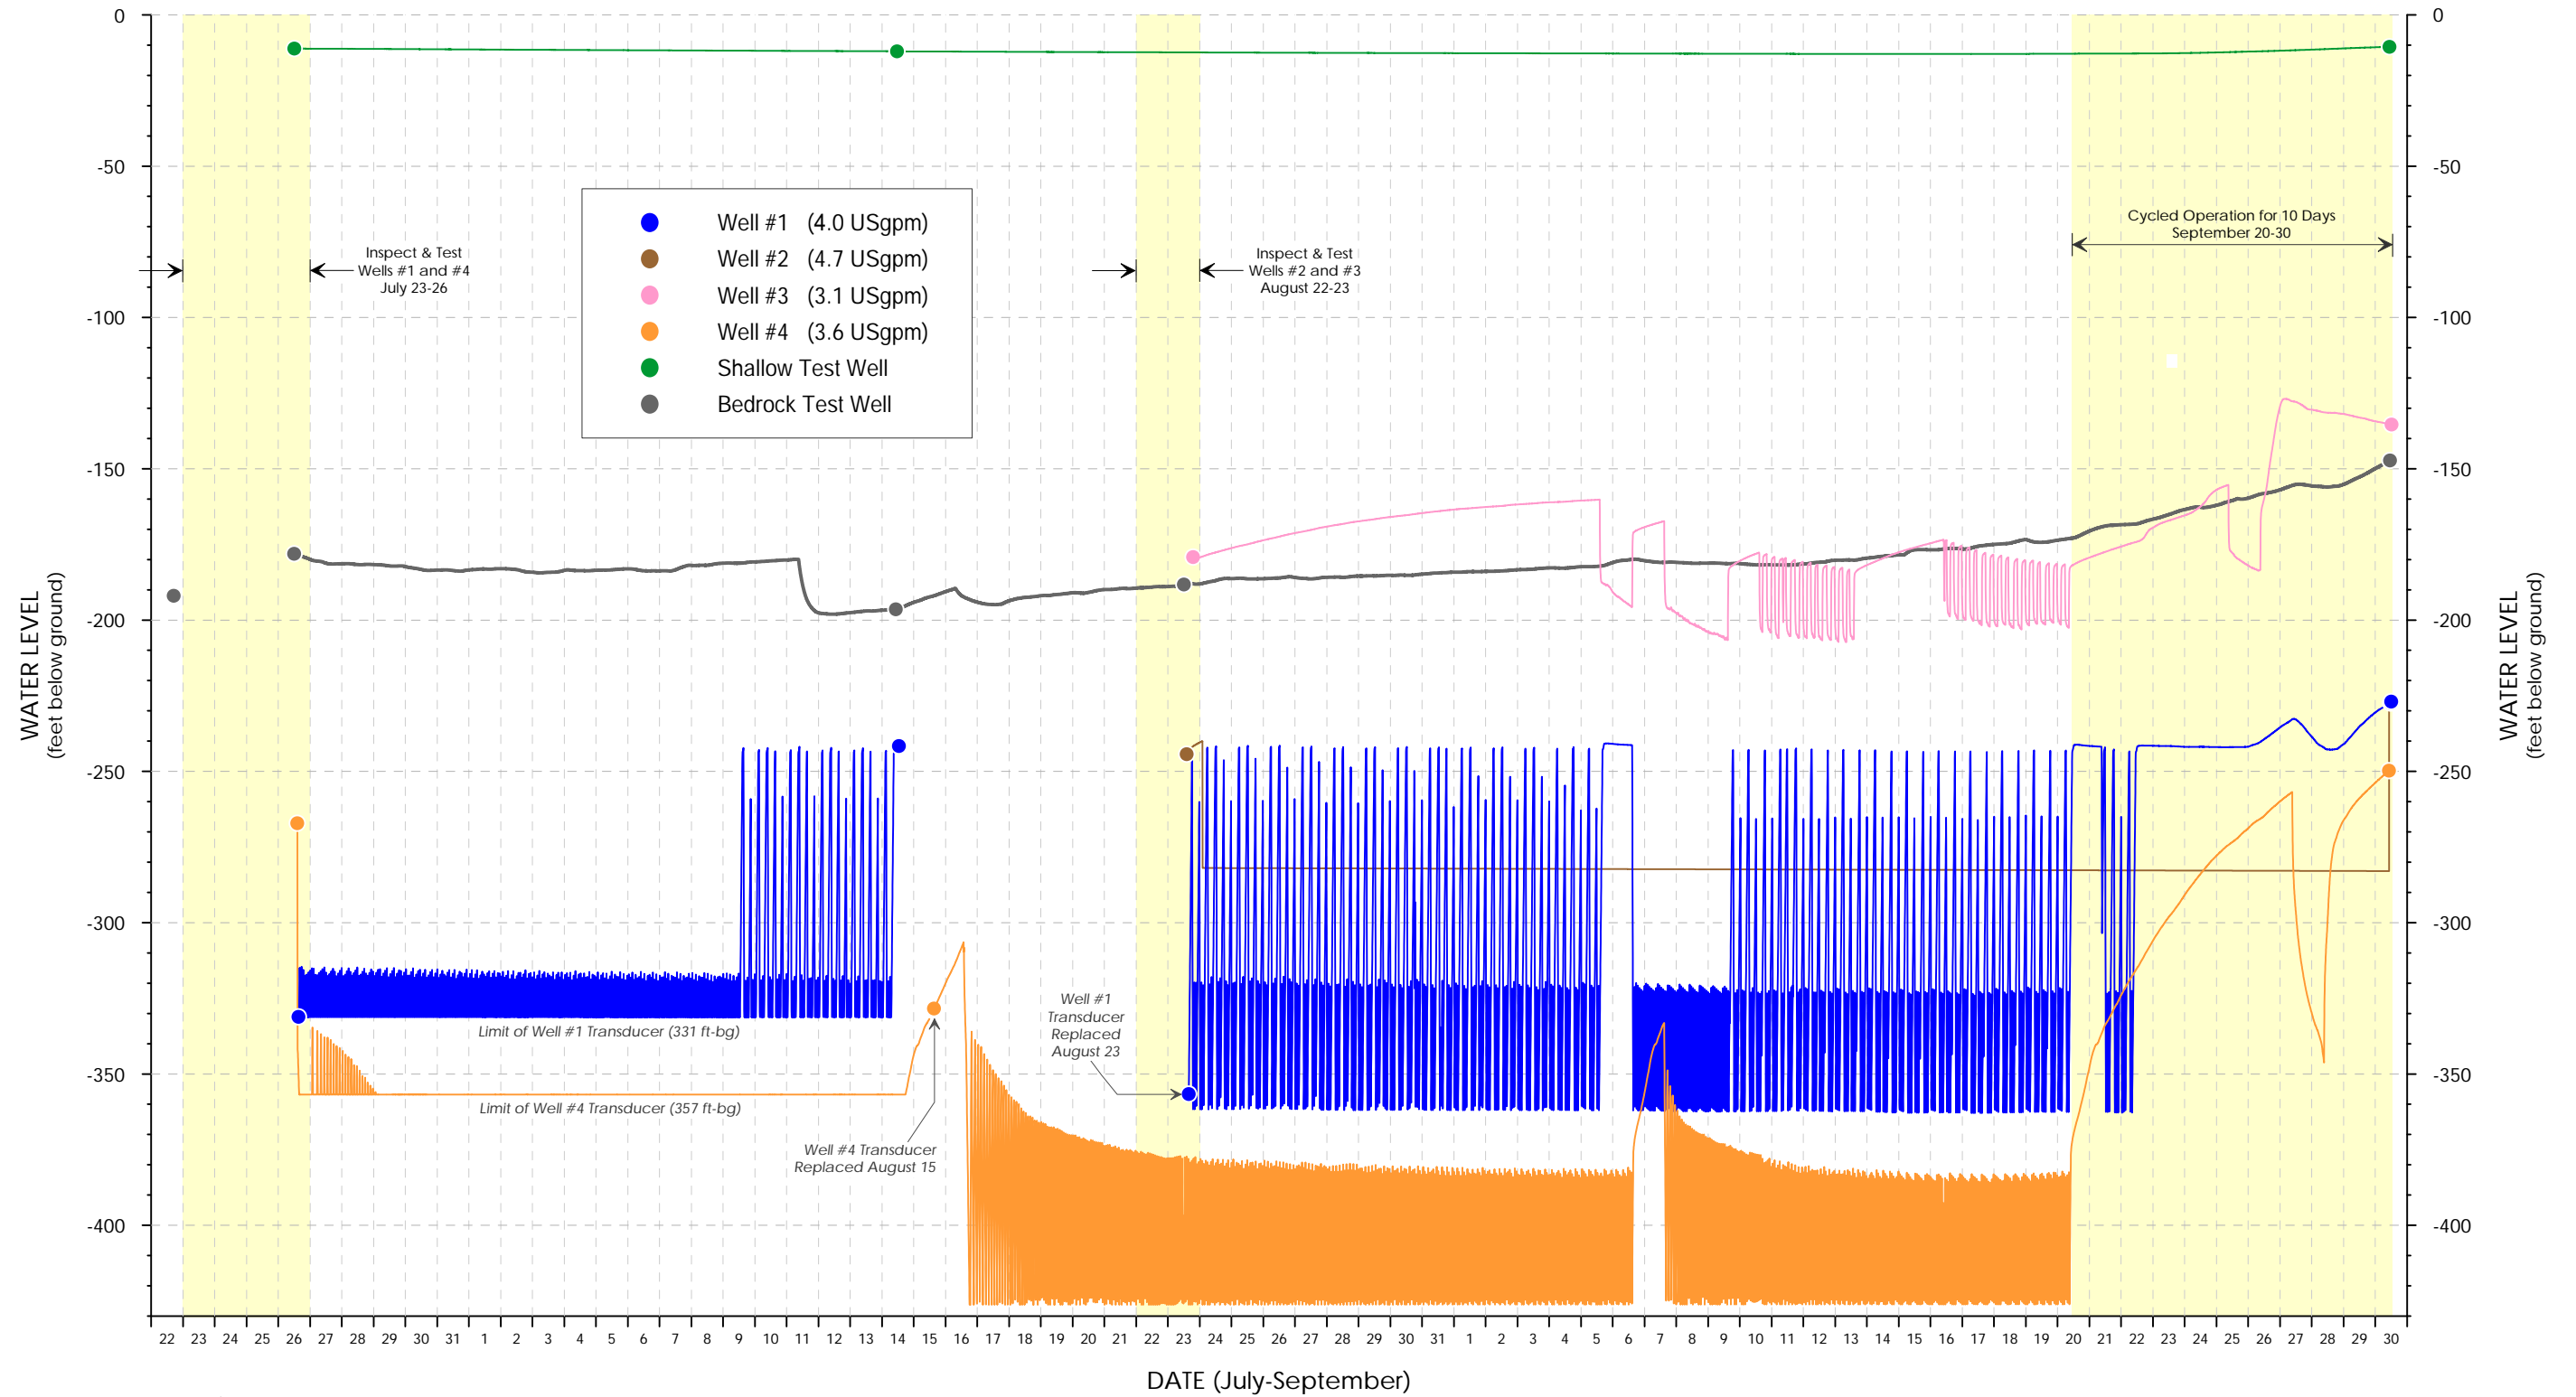
GROUNDWATER MONITORING PROGRAM (July 26 to September 30, 2019)

The resulting 2-month record of BWP wellfield groundwater levels is summarized graphically on Figure 2 (Attachment #4). Data obtained during the period of July 26 to September 20, 2019, are representative of BIM's typical operation of the BWP wellfield, except during the two periods of Phase 2 inspection/testing. Figure 2 data during the 10-day period of September 20-30, 2019, are representative of a prescribed operational sequence comprised of alternating 24-hour intervals of zero withdrawals from the wellfield (to allow measurable aquifer recovery) followed by independent operation of each BWP well at the typical (i.e., default) pumping rate for 24 hours. Monitoring data for the September 20-30, 2019, period of controlled (i.e., sequenced) well operation are also summarized on Figure 3 (Attachment #5).

Routine operation of Well #1 (Figure 2) at approximately 4 USgpm caused water levels to rapidly decline and reduce the entire 128 ft column of water available for drawdown within approximately 2 hours of commencing pumping, followed by a on/off cycling on an approximately 2-hour frequency. This behavior was again observed during the late-September period of independent operation (Figure 3) and verifies that Well #1 was being over-pumped.

Routine operation of Well #2 commenced on August 24, 2019 (Figure 2). The start-up pumping rate of approximately 4.7 USgpm (confirmed by BIM Operations staff) induced an extremely rapid consumption of the water column and the water level then remained relatively stable at approximately 284 ft-bg, which is equivalent to the Well #2 pump intake position. This condition was unchanged throughout both the routine operation period and controlled operation interval (Figure 3). This behaviour was anticipated based on BIM Operations staff's reported observations that Well #2 commonly pumps on a 30-second to 60-second cycle that alternates with non-pumping intervals of the same duration.

Routine operation of Well #3 commenced on August 24, 2019 (Figure 2). The start-up pumping rate of approximately 3.1 USgpm (confirmed by BIM Operations staff) induced a maximum drawdown magnitude of approximately 30 ft (9 m) on September 9, 2019, which infers there was a residual (i.e., available) water column height of approximately 170 ft (52 m) above the Well #3 pump depth of 351 ft-bg. This limited water level drawdown response was also observed during the late-September controlled operation period (Figure 3).

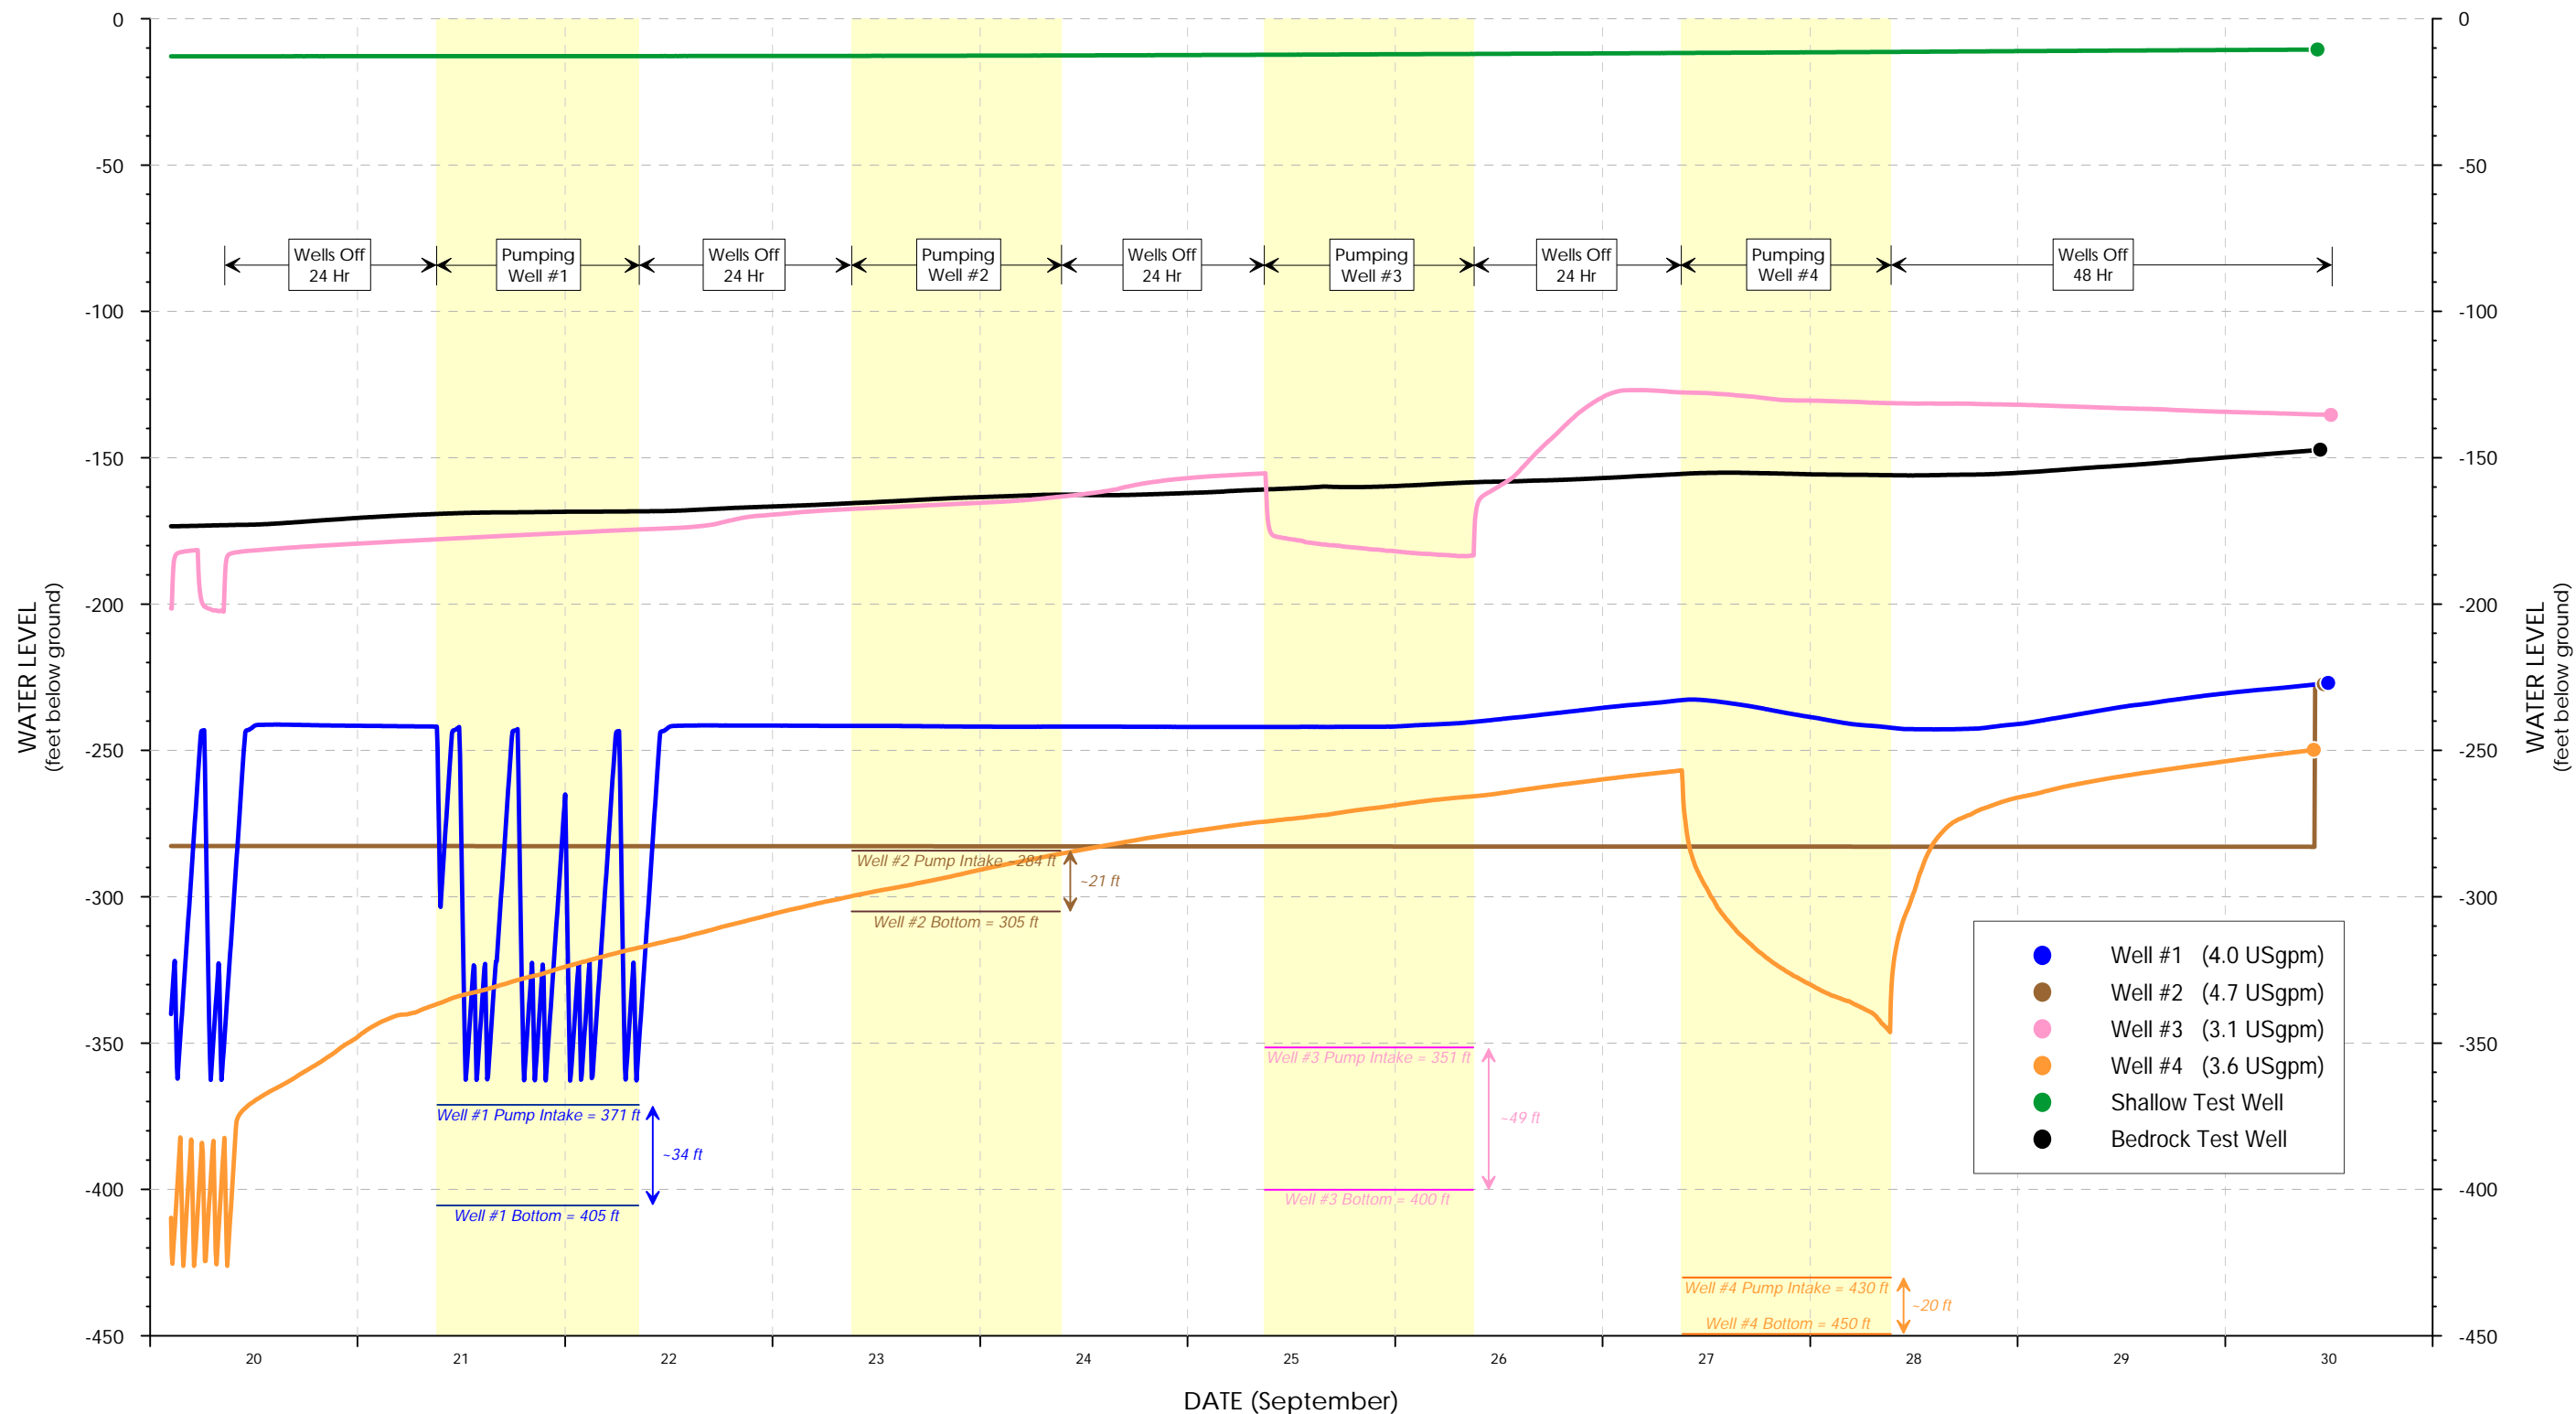
10-Day Cycled Well Operation

Controlled operation of Well #4 (Figure 3) with a start-up pumping rate of approximately 3.6 USgpm (confirmed by BIM Operations staff) induced a maximum drawdown magnitude of approximately 90 ft (27 m), which infers there was a residual (i.e., available) water column height of approximately 140 ft (42 m) above the Well #4 pump depth of 430 ft-bg. This limited water level drawdown response was also observed during the late-September controlled operation period (Figure 3).

Although groundwater levels throughout the wellfield exhibited an overall increasing (i.e., recovery) trend both during and after the late-September controlled pumping period (Figure 3), the observed rate of increase was becoming progressively slower, which indicates aquifer water levels might only partly recover during the 2019/20 winter low-demand, higher-recharge conditions.

The Well #1 pump intake can be dropped an additional 34.0 ft (10.3 m) to the bottom of the well (Figure 3) to reduce the on/off cycling frequency; however, this may not increase the well yield due to the limited increase in available drawdown relative to the known rapid drawdown rate. Likewise, the Well #2 pump can be dropped an additional 21.0 ft (6.4 m) to the bottom of the well, but this modification may neither reduce the on/off cycling frequency nor increase the Well #2 yield, due to the resulting small increase in available drawdown.
