Grafton Lake Watershed Study Report No. 2: 2007-2009

Bowen Island Municipality
(Cove Bay Water System)
981 Artisan Lane, Bowen Island, B.C.
V0N 1G0

Whitehead Environmental Consultants Ltd.
P.O. Box 41, Bowen Island, B.C.
V0N 1G0

February 2010

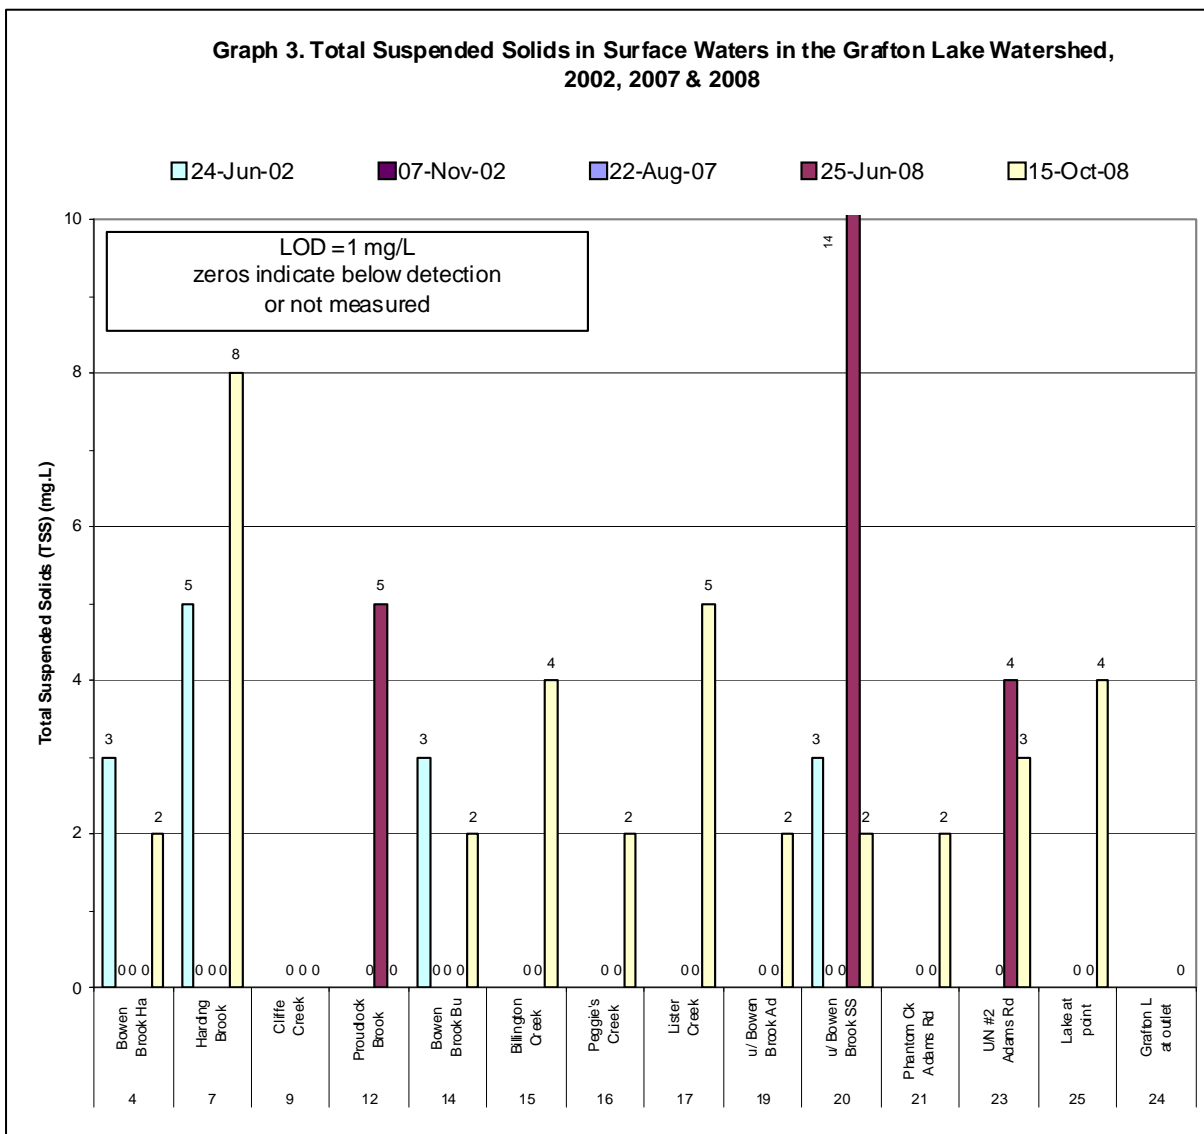
Most TSS measurements ranged from below the detection limit of 1 mg/L to 5 mg/L (Graph 3), except at Harding Brook in June 2008 (8 mg/L) and upper Bowen Brook in October 2008 (14 mg/L). The latter site is at the outlet of a natural wetland that receives water from two constructed ponds (Quarry Park); the suspended matter may have originated as plankton from the ponds and open water within the wetland. Harding Brook is fed in part by a large paved area (the Bowen Building Centre) which provide no runoff detention; this condition exacerbates peak flows during periods of rainfall and likely contributes to the suspension of fine sediments from the low-gradient stream bed between Grafton Road and Harding Road. During periods of lower flow, this flatter reach of Harding Brook is a natural settling area for suspended matter. The overall pattern among sites and between dates is similar to turbidity, with higher values associated with periods of recent precipitation, as might be expected.

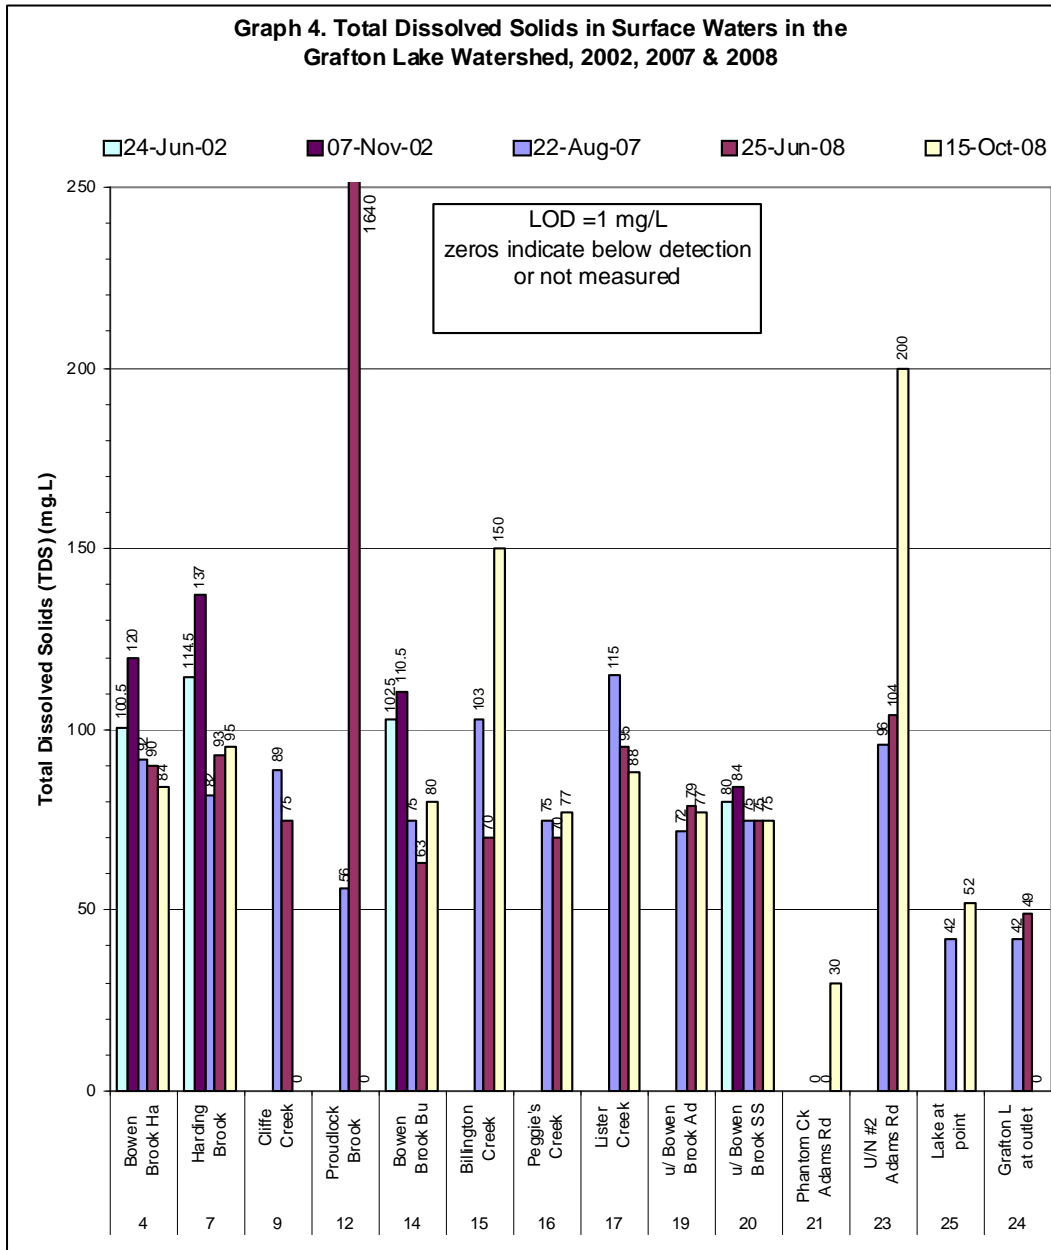
TDS ranged from less than 1 mg/L to 200 mg/L, with most values falling between 50 and 110 mg/L (Graph 4). This range is considered normal. The highest value (1640 mg/L) was recorded in Proudlock Brook in June 2008; this peak coincides with high levels of several other parameters, all of which are suggestive of a human cause.

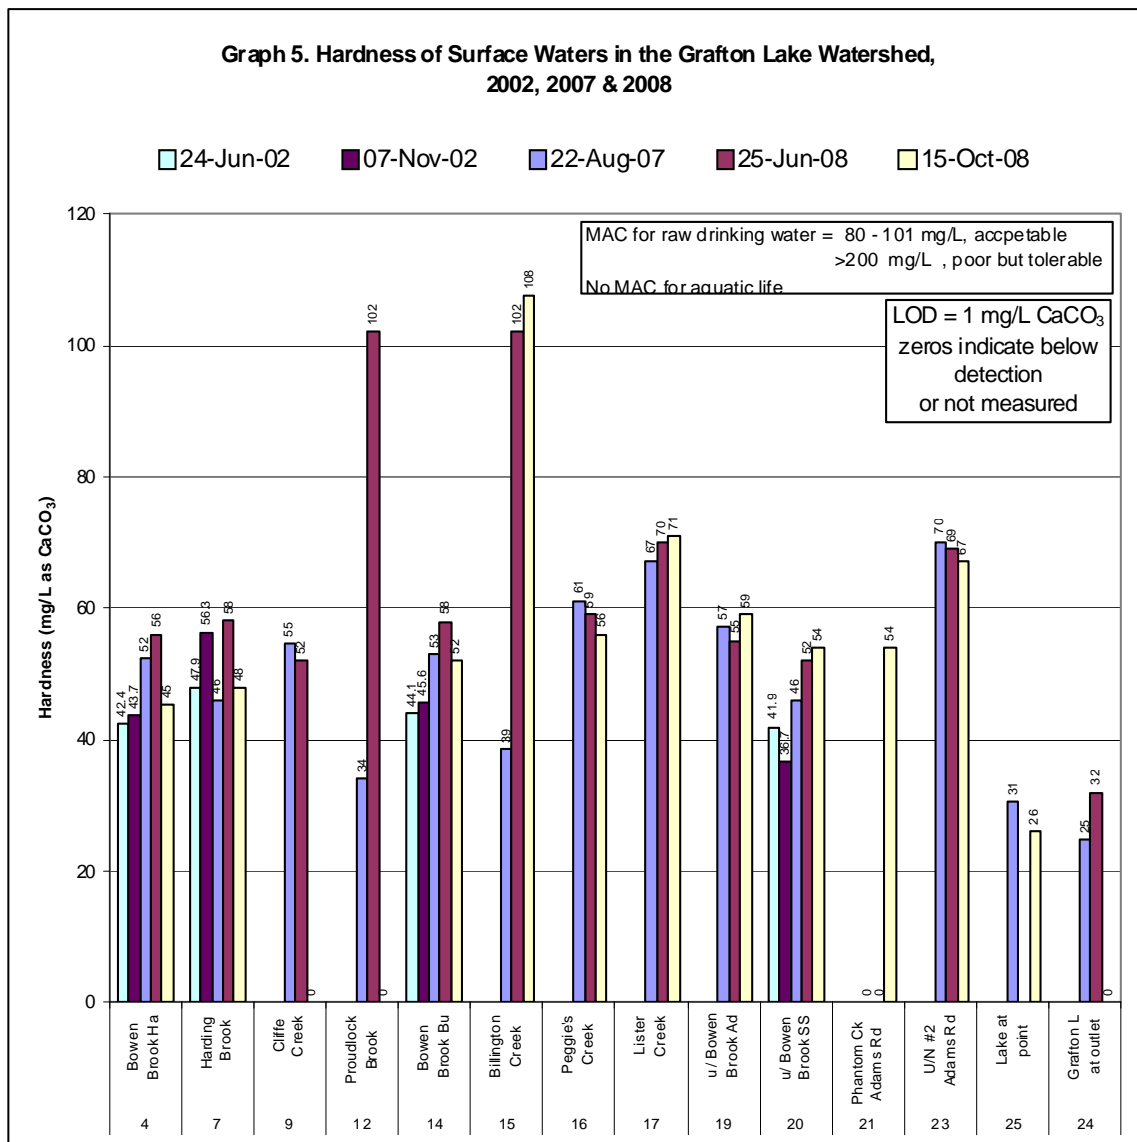
Hardness values at most stations fell between approximately 40 and 70 mg/L (Graph 5). Within sites, values tended to be variable, although increasing trend was notable in all sites on Bowen Brook; the reasons for the trends are not known. Peak values were recorded in Billington Creek (102 and 108 mg/L in June and October 2008), and Proudlock Brook (102 mg/L) in June 2008. These high values appear to be related to land uses in the catchments. Hardness of Grafton Lake water was the lowest on any sampling occasion, with values below 32 mg/L. The hardness/softness of the water determined the MACs for aluminum (Al), cadmium (Cd), chromium (Cr) and lead (Pb).

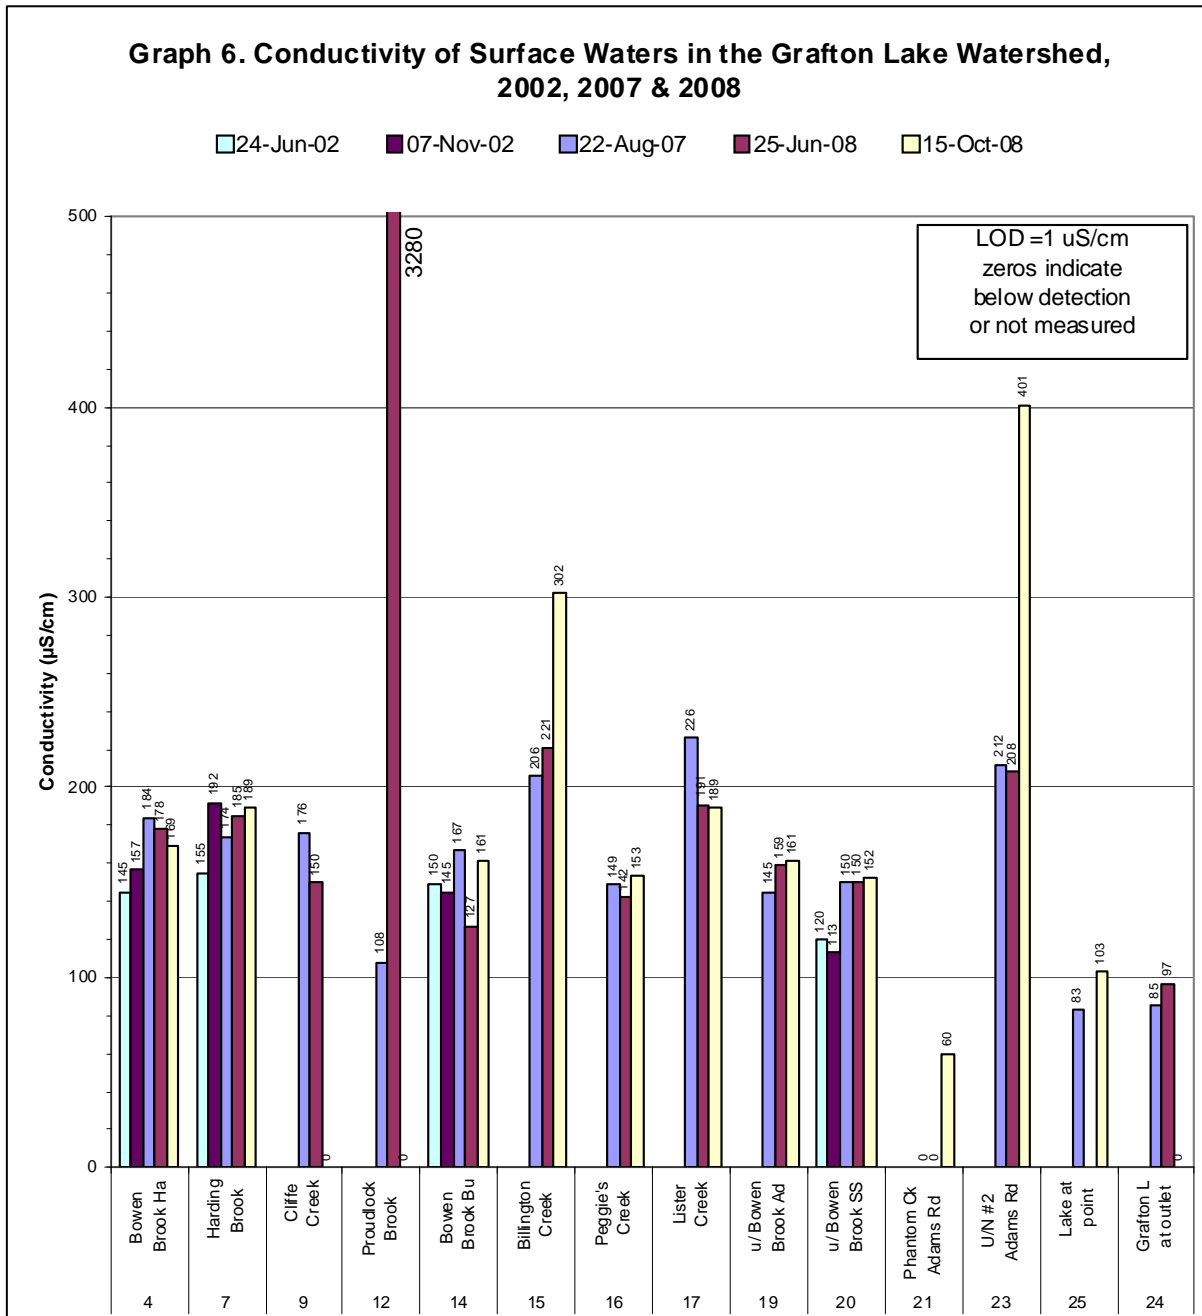
Conductivity of water sampled at most stations on most dates fell within the range of approximately 100 – 200 $\mu\text{S}/\text{cm}$ (Graph 6). The lowest values, 60 $\mu\text{S}/\text{cm}$ was measured in Phantom Brook in October 2008. Conductivity in Grafton Lake ranged between 83 and 103 $\mu\text{S}/\text{cm}$, well below the average for the streams. An extreme peak value of 3280 $\mu\text{S}/\text{cm}$ was recorded in Proudlock Brook in June 2008; this anomaly is thought to reflect inputs of man-made chemicals in the watershed (see pH, Ammonia and Phosphate). Other high values, possibly indicative of human impacts, occurred in unnamed #2 at Adams Road and in Billington Creek, both in October 2008.

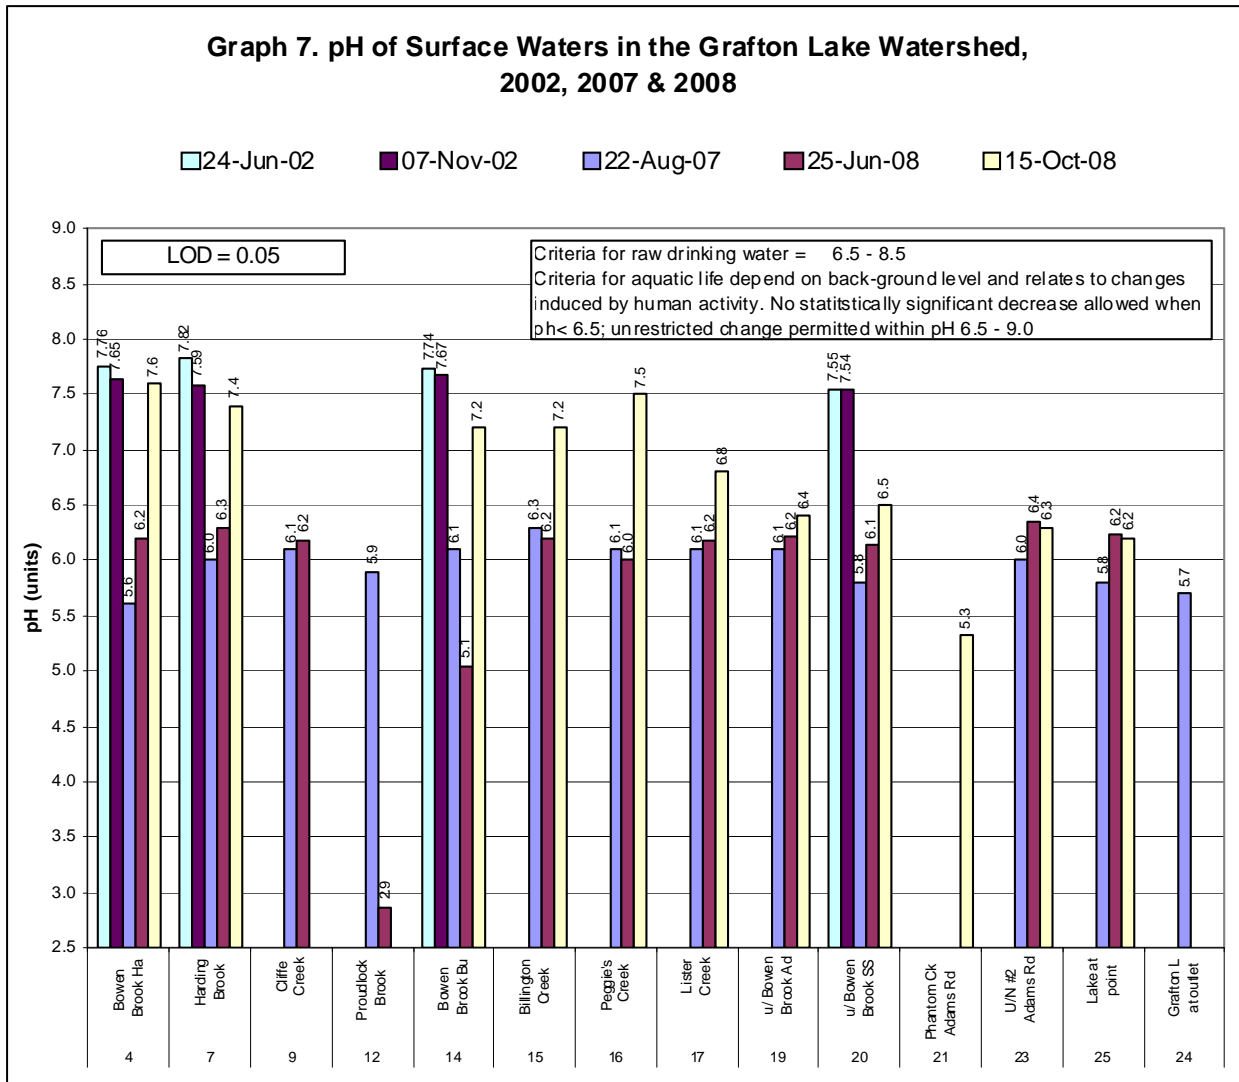
Water pH measurements tended to cluster around the range of 6.0 to 7.0 (Graph 7). Many readings fell slightly below the desirable range of 6.5 – 9.0, as is common in south coastal B.C due to naturally high acidity caused by high rainfall. Values at the high end of the ranges were close to neutral (6.8 – 7.8), while the low values ranged from 5.5 to 6.3. An exceptionally low pH value was recorded in Proudlock Brook in August 2008; the extremely high acidity would have been toxic to aquatic life. This acidity, which coincided with high levels of ammonia, organic-N and phosphate in this stream, strongly suggests that the cause of this anomaly may have been agricultural fertilizer. Measurements below 6 were recorded in Bowen Brook (Sunset Road, Buchanan Road and Harding Road), as well as Grafton Lake; these values are all considered natural. The slightly acid conditions determined the MACs for aluminum, manganese, mercury and ammonia.

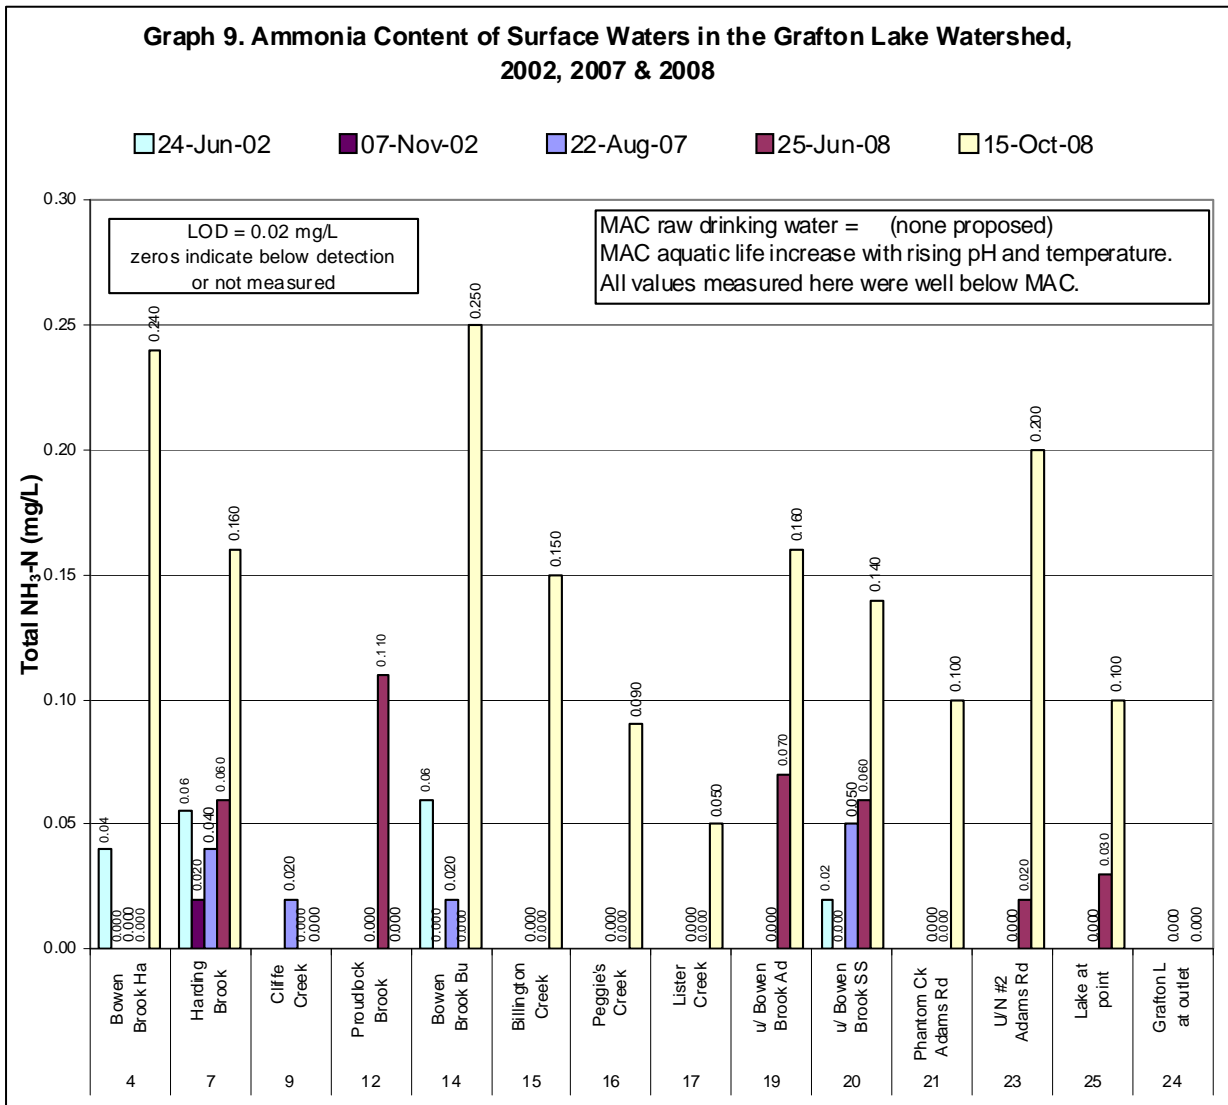
Ammonia-N (Graph 9) ranged from below detection (<0.02 mg/L) to 0.25 mg/L. The highest values within each creek tended to occur in October 2008. In August 2008, NH₃-N in Proudlock Creek was the highest (0.110 mg/L) among all measured streams. Ammonia-N content in Grafton Lake was generally very low, only being detectable in August and October 2008. A trend of increasing ammonia was evident between 2002 and 2008; the causes of this trend are not yet clear. All NH₃-N values measured were well below the MAC for aquatic life (there is no MAC or guideline for drinking water).

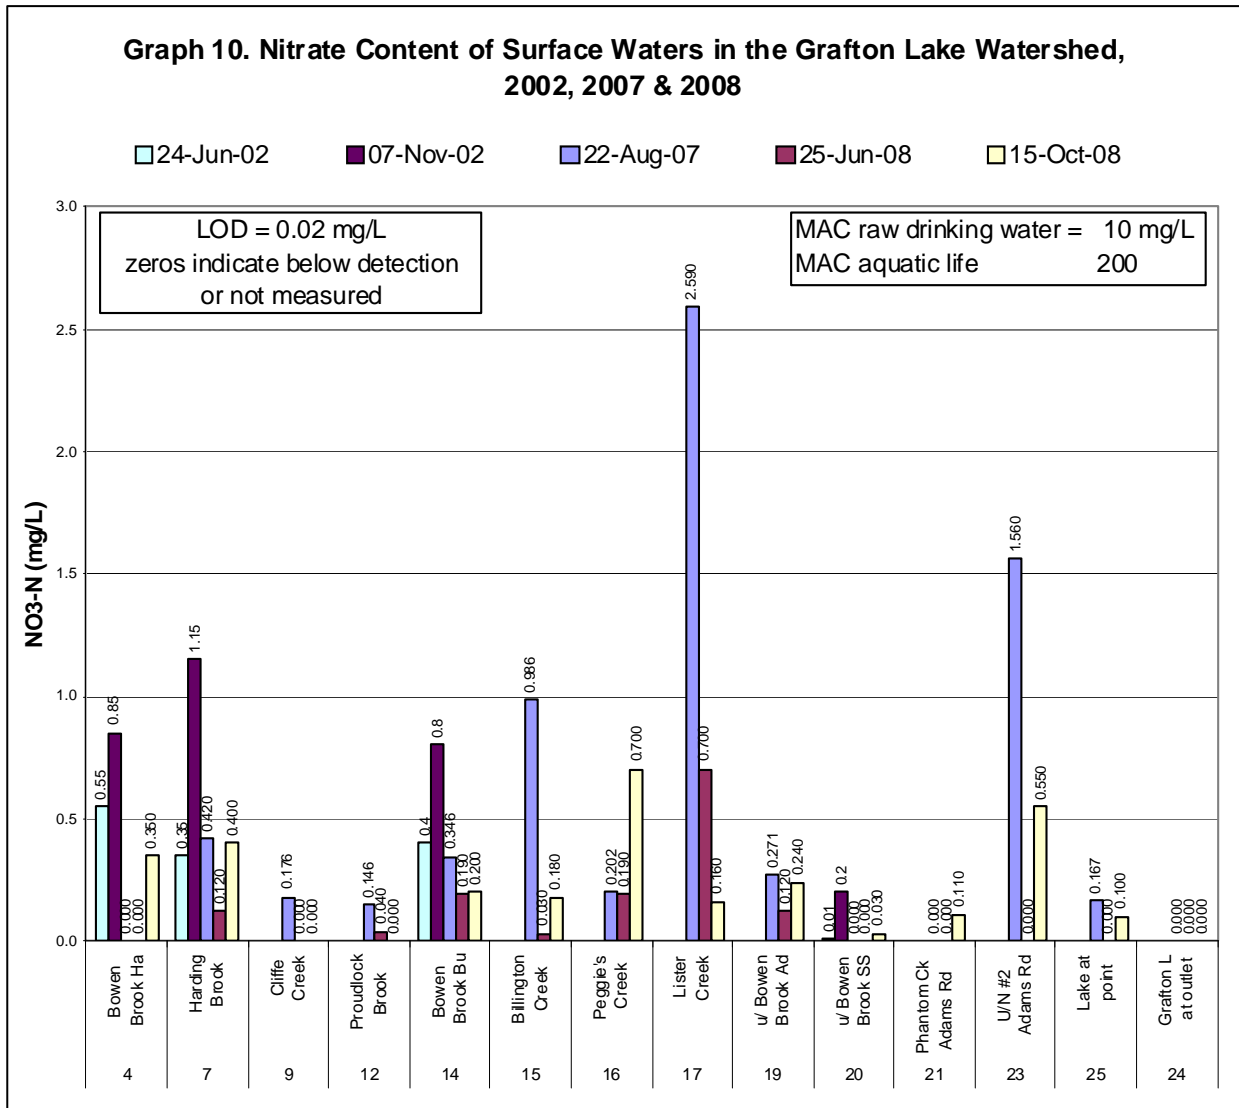
Nitrate-N concentrations (Graph 10) were consistently below 1.0 mg/L, with most sites showing less than 0.05 mg/L and only two sites reporting values above 1.5 mg/L. The maximum values, 2.50 and 1.56 mg/L, were recorded in Lister Creek and unnamed #2 in August 2007. Land uses in the catchments of both these streams are relatively dense residential, which suggests that the elevated NO₃-N concentrations may be due, at least in part, to human activities such as gardening, hobby farming and, possibly, septic fields. We note, however, that none of the readings exceed the MAC for drinking water.

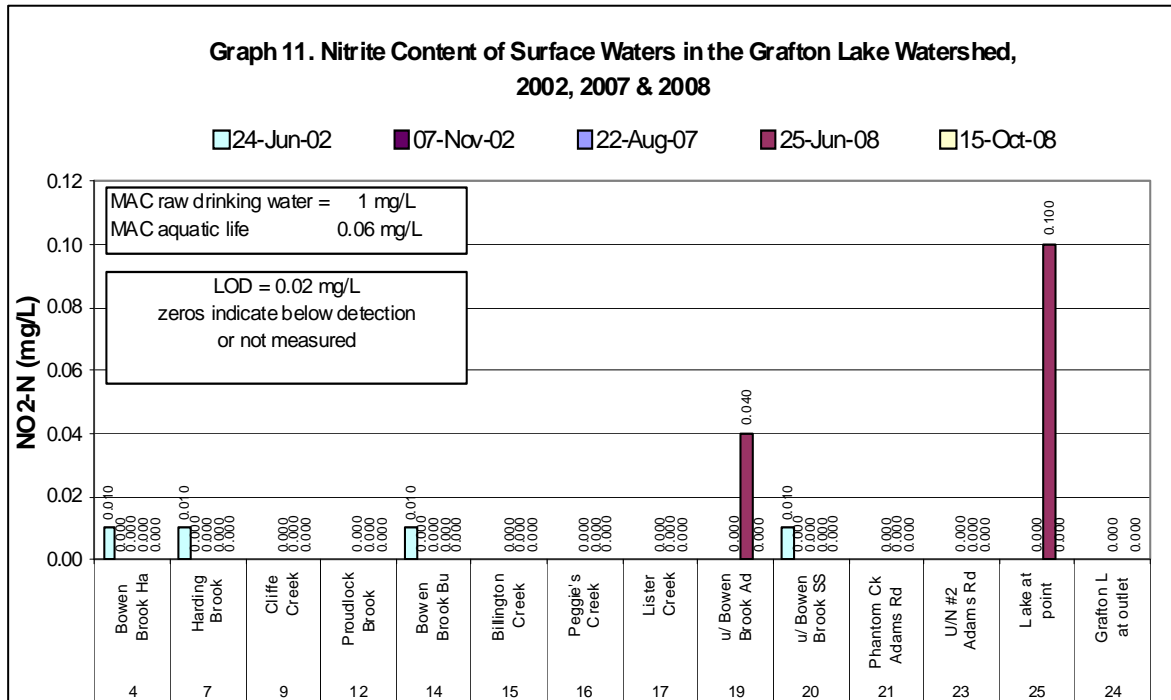
Nitrite-N concentrations (Graph 11) have tended to be less than the laboratory detection limit of 0.01 mg/L. However, higher values were recorded in June 2008 at upper Bowen Brook at Sunset (0.04 mg/L) and in Grafton Lake (0.10 mg/L). While none of the results exceeded the MAC for drinking water, the latter value at Grafton Lake did exceed the MAC for aquatic life.

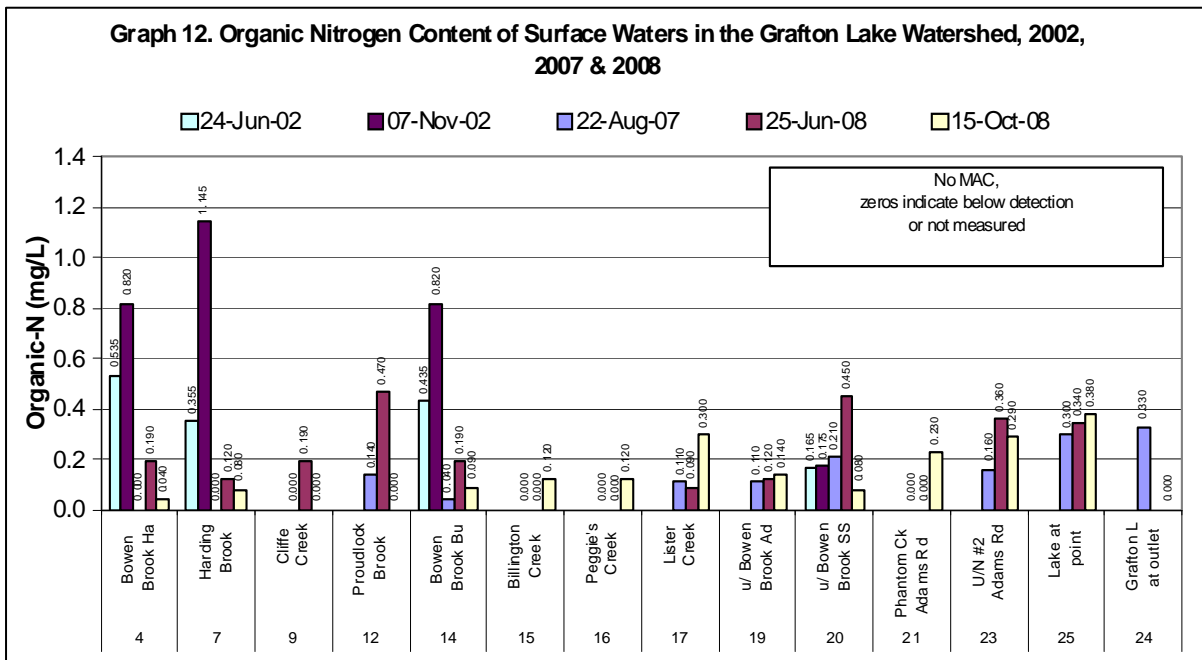
Organic nitrogen (Graph 12) was generally less than 0.4 mg/L at most stations. However, values above 0.8 mg/L were recorded in November 2002 in Bowen Brook at all elevations, and in Harding Brook. Values for Grafton Lake ranged between 0.30 and 0.38 mg/L, higher than in most streams on the same dates.

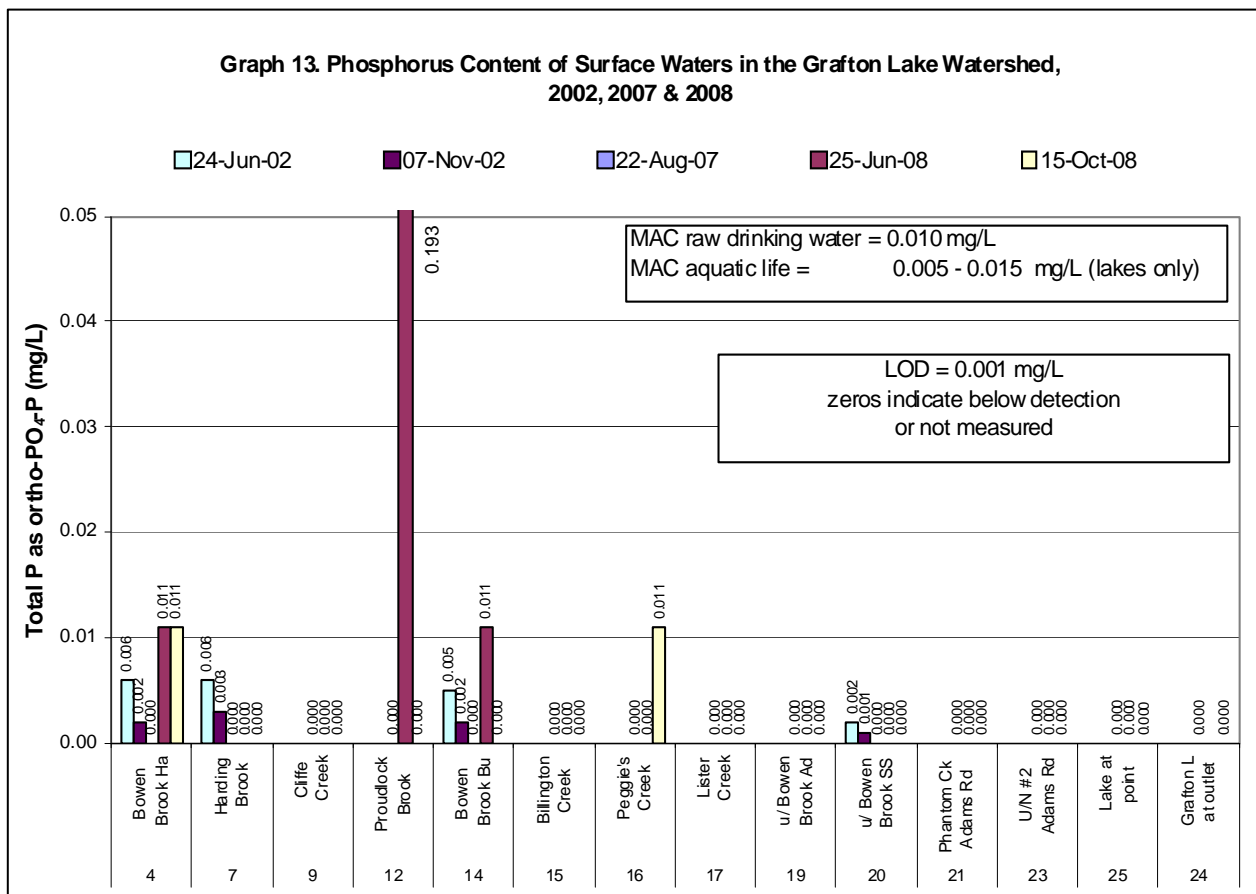
Phosphate-P concentrations (Graph 13) in 2007-2008 were almost entirely below the 0.01 mg/L detection limit used³. Values recorded in 2002, when a detection limit of 0.001 mg/L was employed, ranged between ≤ 0.001 mg/L and 0.006 mg/L. Bowen Brook (at Harding Road, Buchanan Road and Sunset Road) and Harding Brook at Harding Road were the only sites where PO₄ was measured in 2002. The maximum value, an exceptional 0.193 mg/L, was recorded in Proudlock Brook in June 2008. This peak value appears to be related to human activity in this subwatershed, possibly the use of fertilizer (see nitrogen and sulphate). PO₄-P concentrations in 2008 at this site, as well as in Bowen Brook at Harding Road and at Buchanan Road and Peggie’s Creek, slightly exceeded the MAC for drinking water; the MAC for aquatic life was only exceeded in Proudlock Brook in June 2008. The PO₄-P concentrations observed in Grafton Lake suggest that it is not affected by phosphorus enrichment from human sources (i.e., oligotrophic).

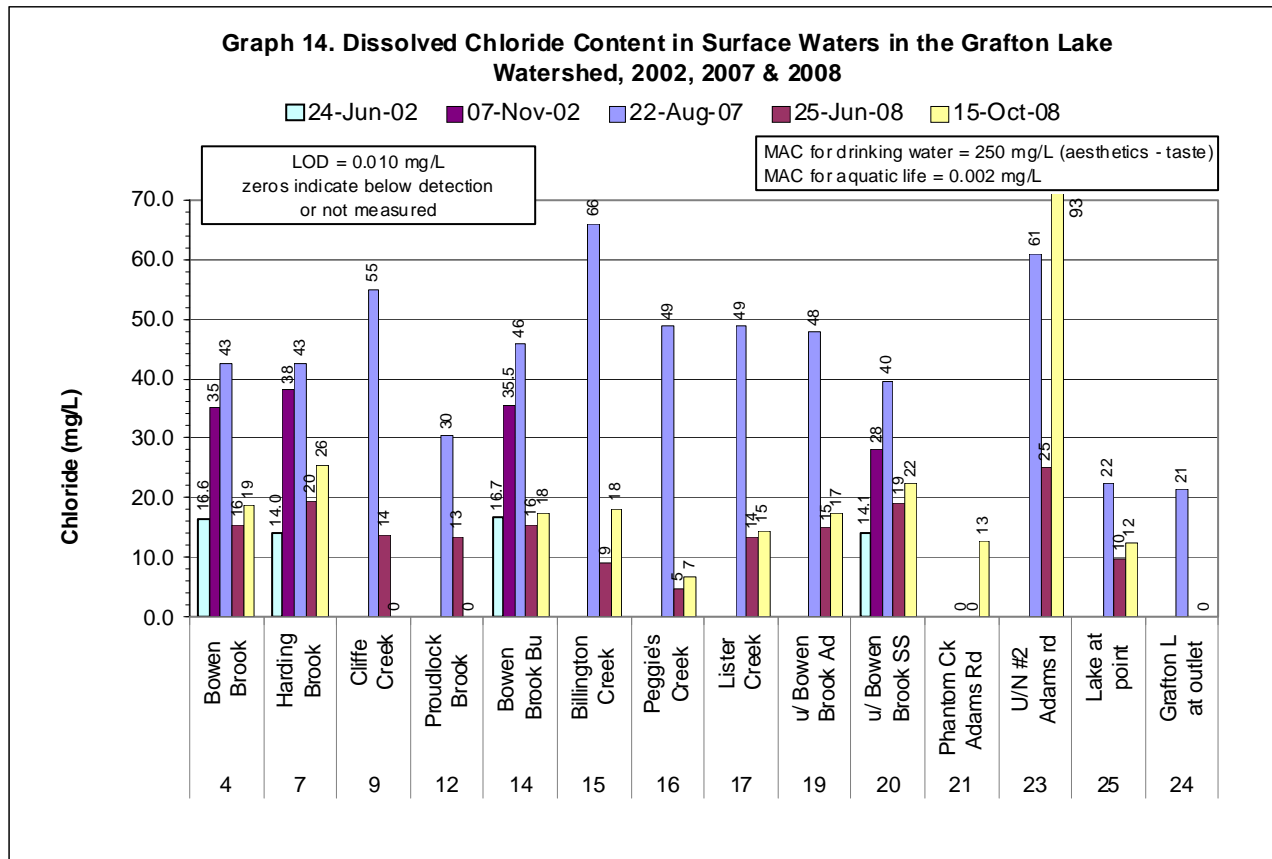
Chloride (is examined here to ascertain whether the use of road salt during the winter has a measurable residual effect on water quality. Dissolved chloride concentrations ranged between 5 and 93 mg/L Cl⁻, with most values under 20 mg/L (Graph 14). This range is well below the MAC of 250 mg/L for drinking water, which is based on aesthetics (taste). The highest concentrations within streams were measured in August 2007, during conditions of summer low flow and minimum dilution by runoff. At that time, showed Cl⁻ content in all but one stream was ≥40 mg/L. The lowest concentrations were recorded in June 2008 under conditions of moderate dilution by recent rainfall. The peak value (93 mg/L Cl⁻) was measured in Unnamed #2 at Adams Road in October 2008 under “first flush” conditions, when other streams presented Cl⁻ concentrations of 7 – 26 mg/L. This result, while suggestive of a chloride release of within the catchment, possibly from scouring of road salt-containing sediment in the roadside ditches, does not coincide with a correspondingly high value for sodium (Graph 20). Instead, it is more suggestive of a release of chlorinated water, for example from a swimming pool or another man-made source.

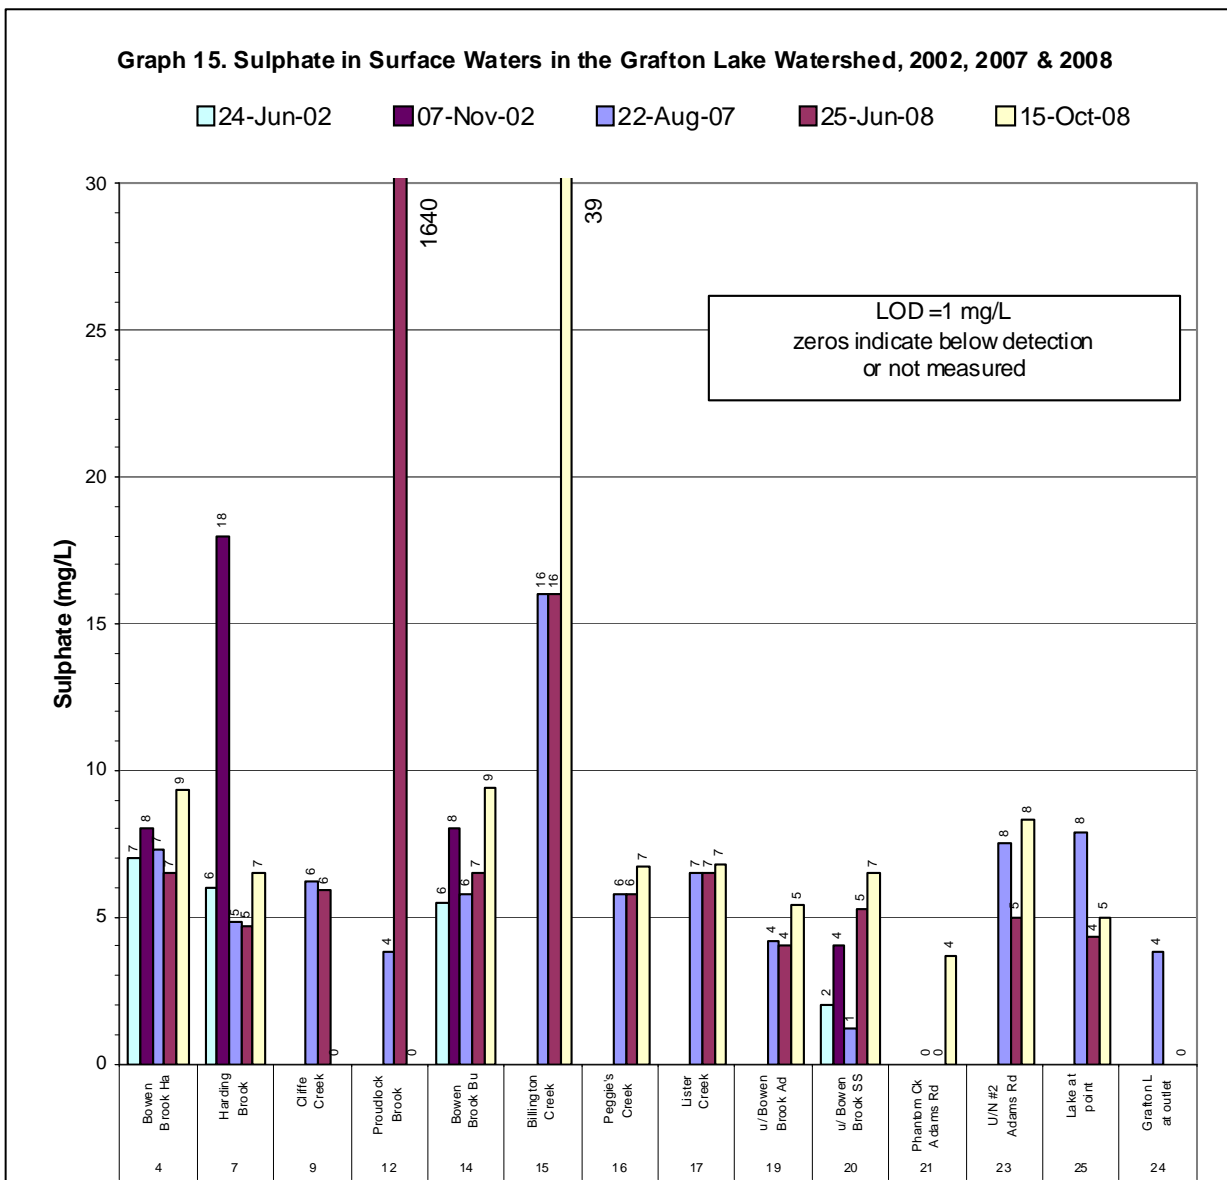
Sulphate concentrations at most sites was consistently below 10 mg/L and well below the 500 mg/L MAC (Graph 15). Above average values were recorded in all of the catchments most affected by human activity: Harding Brook in 2002, Billington Creek in 2007 and 2008 and Proudlock Brook in 2008. The highest value, 1640 mg/L, occurred in Proudlock Creek in June 2008, the same occasion that this stream reported exceptionally high concentrations of phosphorus, and TDS together with very high conductivity and turbidity and very low pH. The second-highest reading, 39 mg/L, occurred in Billington Creek in October 2008; this stream, not sampled in 2002, also showed above average values (16 mg/L) in August 2007 and July 2008. As indicated previously, land uses in the catchment of Billington Creek include a quarry, heavy duty mechanics shop and incineration of woody debris. Harding Brook reported 18 mg/L in November 2002; its catchment includes hobby farms and a lumber yard. The sulphate results indicate that land uses in the catchments of these three streams are having a measurable adverse effect on surface water quality.

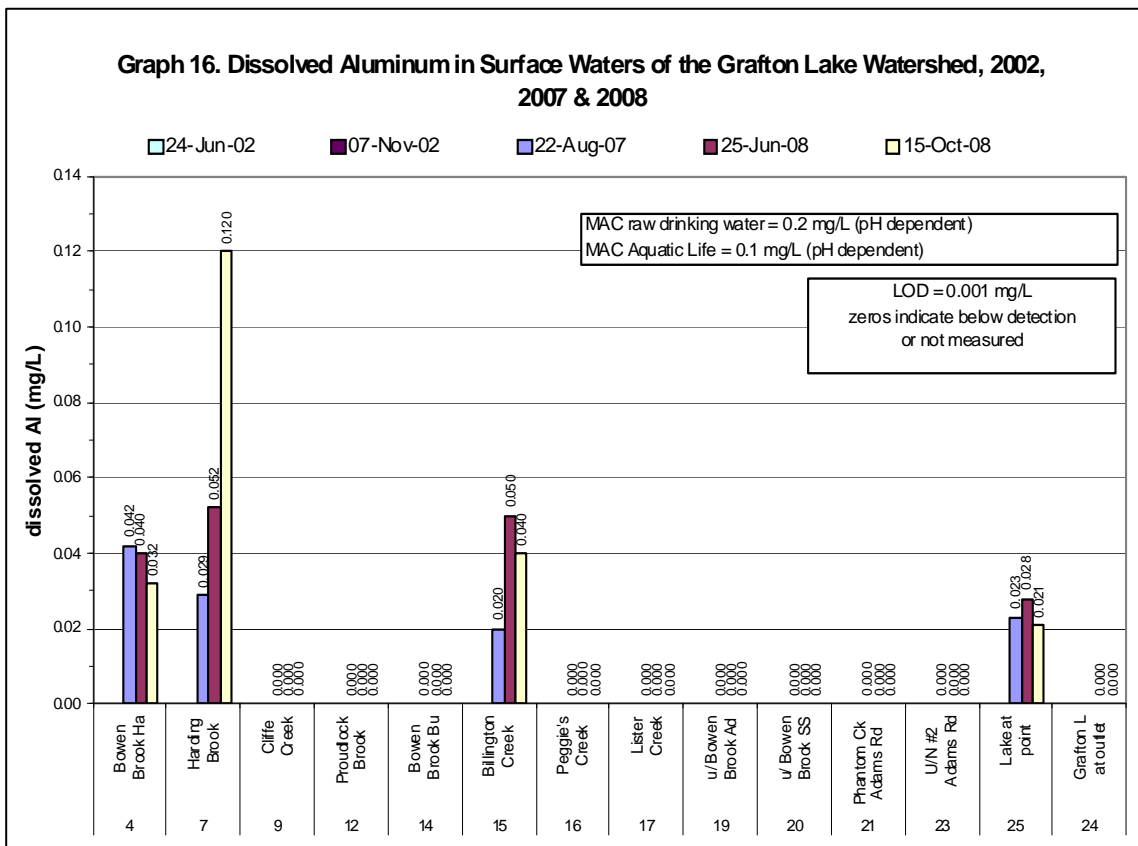
Dissolved aluminum was measured only in 2007-2008 (Graph 14). Most readings ranged between 0.02 and 0.05 mg/L, and all but one site showed values below the MACs for drinking water and aquatic life. Harding Brook, however, reported 0.120 mg/L in October 2008, which exceeds the MAC for aquatic life. On this date, which represented fall first-flush conditions, >79% of total-Al occurred as dissolved form, compared to <25% on the previous two sampling dates which represented low to moderate flow conditions.

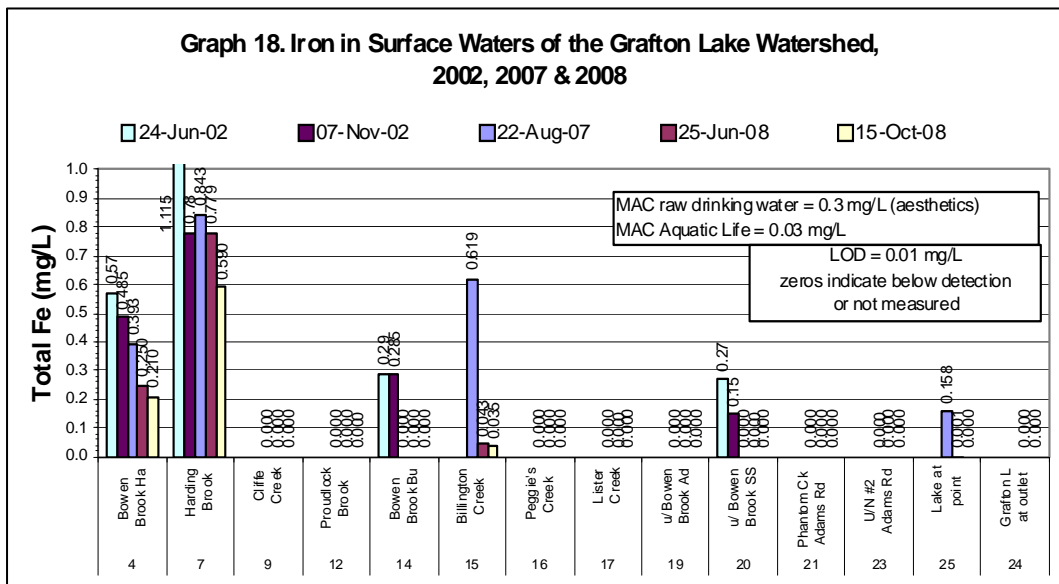
Iron concentrations ranged between 0.001 – 0.115 mg/L and often exceeded the MACs for drinking water, particularly in Bowen Brook at Harding Road, Harding Brook and (on one occasion) in Billington Creek (Graph 18). The highest values on any date were recorded in Harding Brook and the lowest in Grafton Lake. Overall, there appears to have been a trend of decreasing Total-Fe content over time at all sites measured, although the Fe content in Harding Brook remains high compared to other sites. Most of the Fe present in the waters was in the dissolved form. Since the water quality issue regarding Fe is aesthetics (taste and staining) rather than public health, the values recorded are not considered a concern.

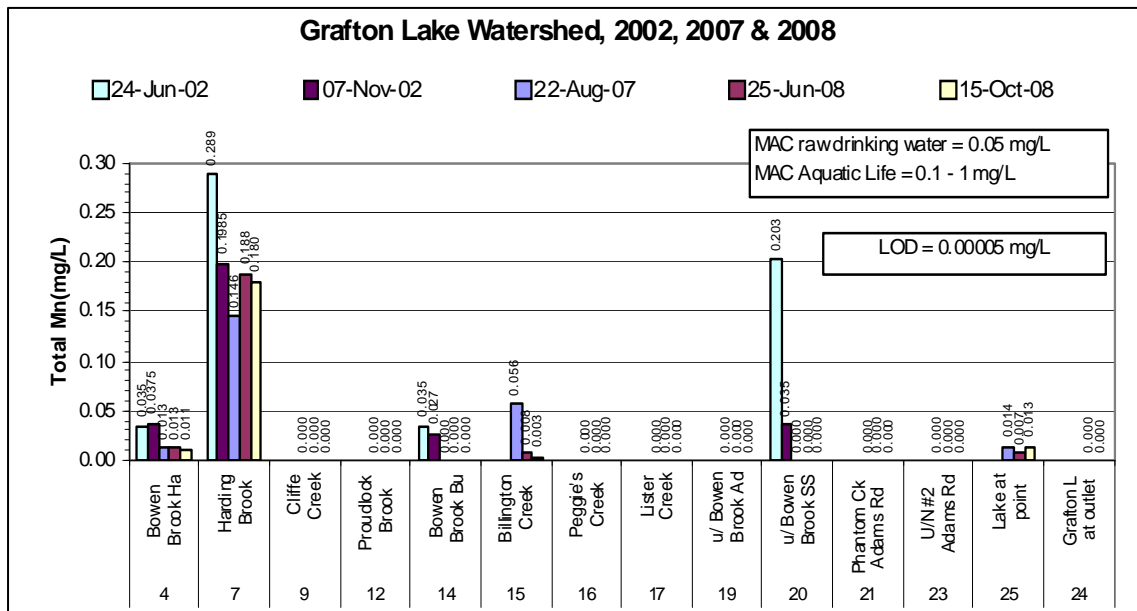
Total manganese was usually present in low concentrations in most sites sampled, except in Harding Brook, where the readings were consistently several times higher than at other locations and exceeded the MAC for drinking water and aquatic life (Graph 19). The dissolved fraction always represented > 80% of total-Mn in all streams. The other exceedances of the drinking water MAC were recorded in Bowen Brook at Sunset Drive in June 2002 and, to a much lesser extent, Billington Creek in August 2007. Since the drinking water MAC for Mn is related to staining and taste, rather than public health, these results are not considered a cause for concern.

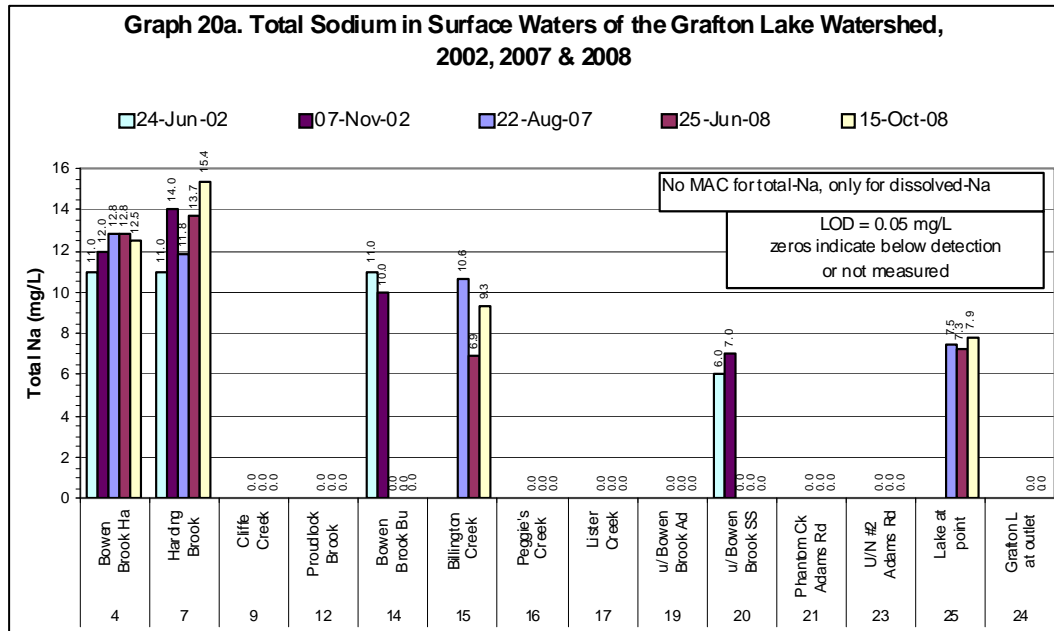
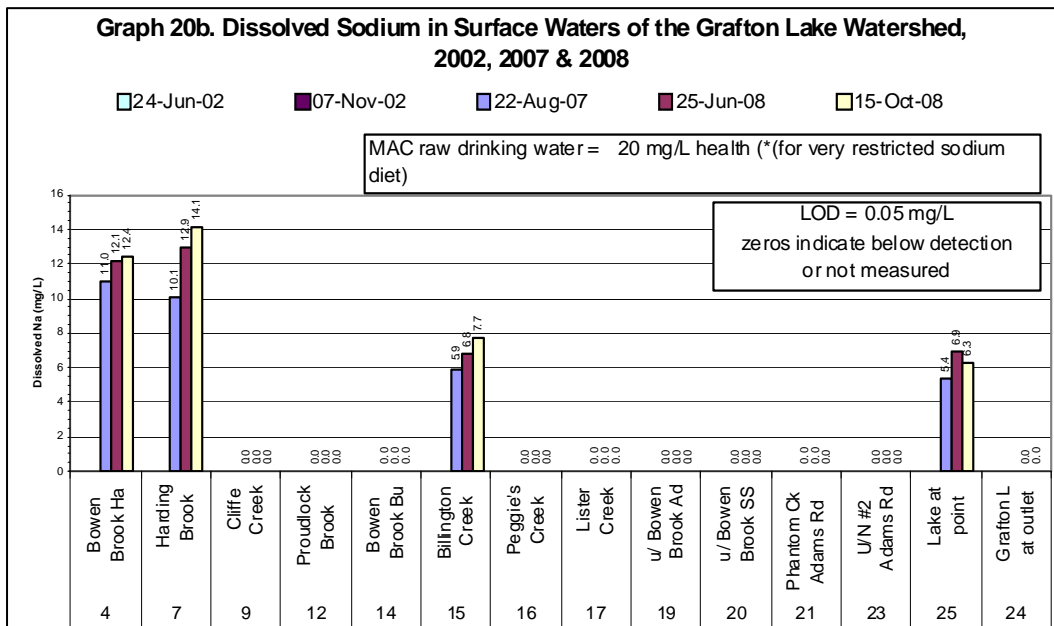
Concentrations of total sodium ranged from 6.0 – 15.4 mg/L, with most (56-97%) occurring in dissolved form when present at detectable concentrations (Graphs 20a and 20b). The content of sodium in stream waters tended to increase from the upper to the lower watershed, while Grafton Lake exhibited low values (7.3- 7.9 mg/L). This element was observed because of the extensive use of road salt during winter; however, the low variation between sampling dates and generally low concentrations suggest that sodium content in the Grafton Lake source water does not present a concern.

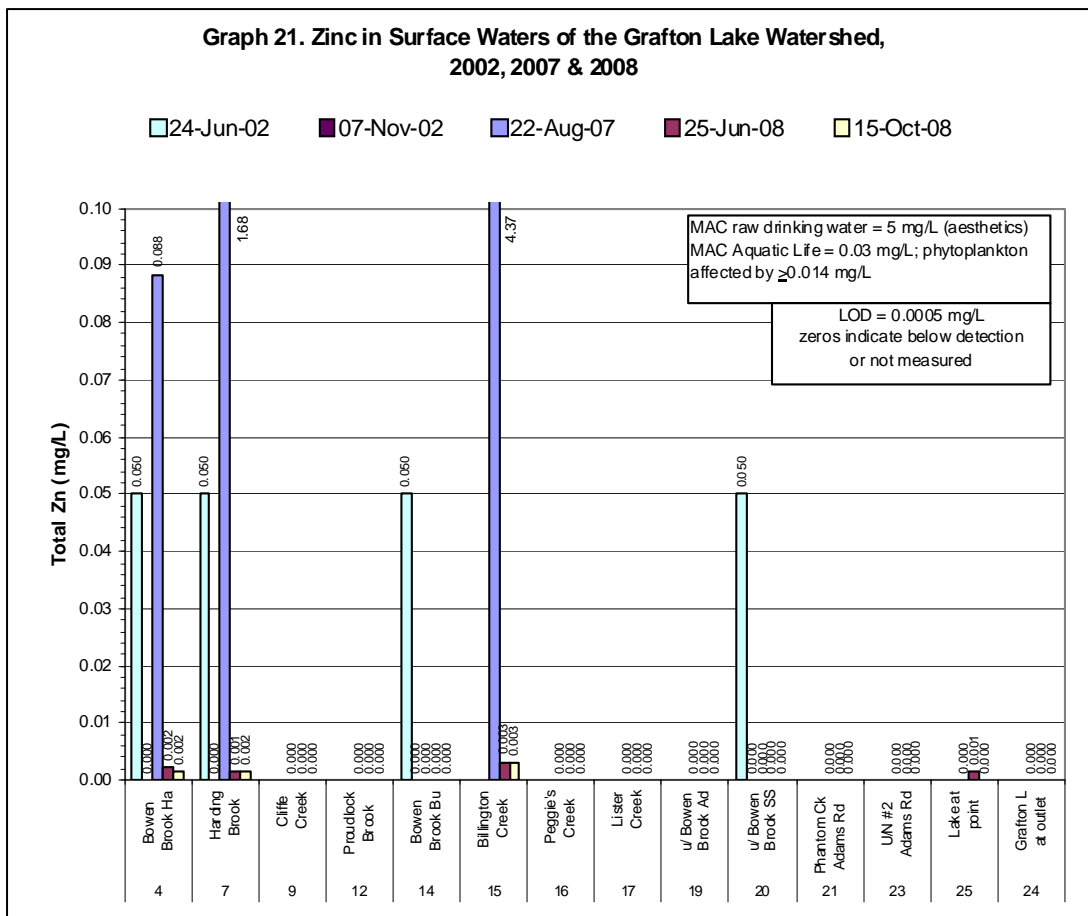
Concentrations of total zinc ranged from undetectable (<0.0005 mg/L) to over 4 mg/L, with most values being less than 0.005 mg/L (Graph 21). Total-Zn content in Grafton Lake was always <0.001 mg/L. Exceptionally high concentrations of Zn were recorded on this date in Billington Creek (4.37 mg/L), lower Bowen Brook (1.68 mg/L) and Harding Brook (0.88 mg/L) on 22 August 2007, all of which exceeded the MACs for aquatic life. Dissolved zinc predominated (>80%) on all dates except during summer low flow conditions in August 2007, when the particulate fraction was >98% in all samples. The reason for the peak Zn values in all streams (and not the lake) on this date coinciding with the predominance of particulate Zn is unknown; however, factors that may have contributed to such an occurrence include precipitation from groundwater discharges into the streams, deposition of Zn-rich dust, and/or other causes. The MAC for drinking water was not exceeded on any occasion.
