Grafton Lake Watershed Study Report No. 2: 2007-2009

Bowen Island Municipality
(Cove Bay Water System)
981 Artisan Lane, Bowen Island, B.C.
V0N 1G0

Whitehead Environmental Consultants Ltd.
P.O. Box 41, Bowen Island, B.C.
V0N 1G0

February 2010

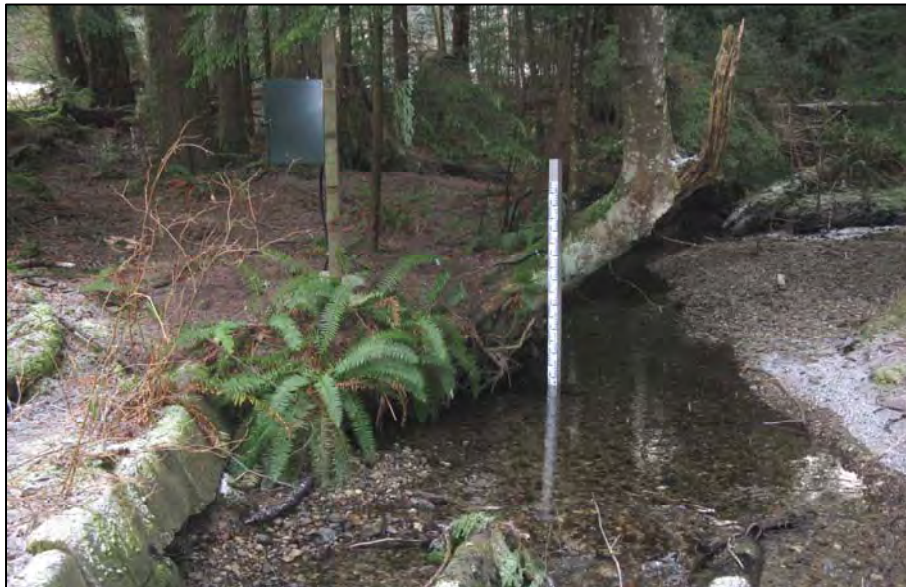
Photo 4-1. Automated hydrometric station on Bowen Brook viewed from Harding Road. A limited number of stage and stream flow measurements have been completed to date for the Municipal hydrometric station; however, these are insufficient to allow accurate estimation of stream flows from the water level readings. Accordingly, the analysis provided in this report is based on stage values rather than discharge.

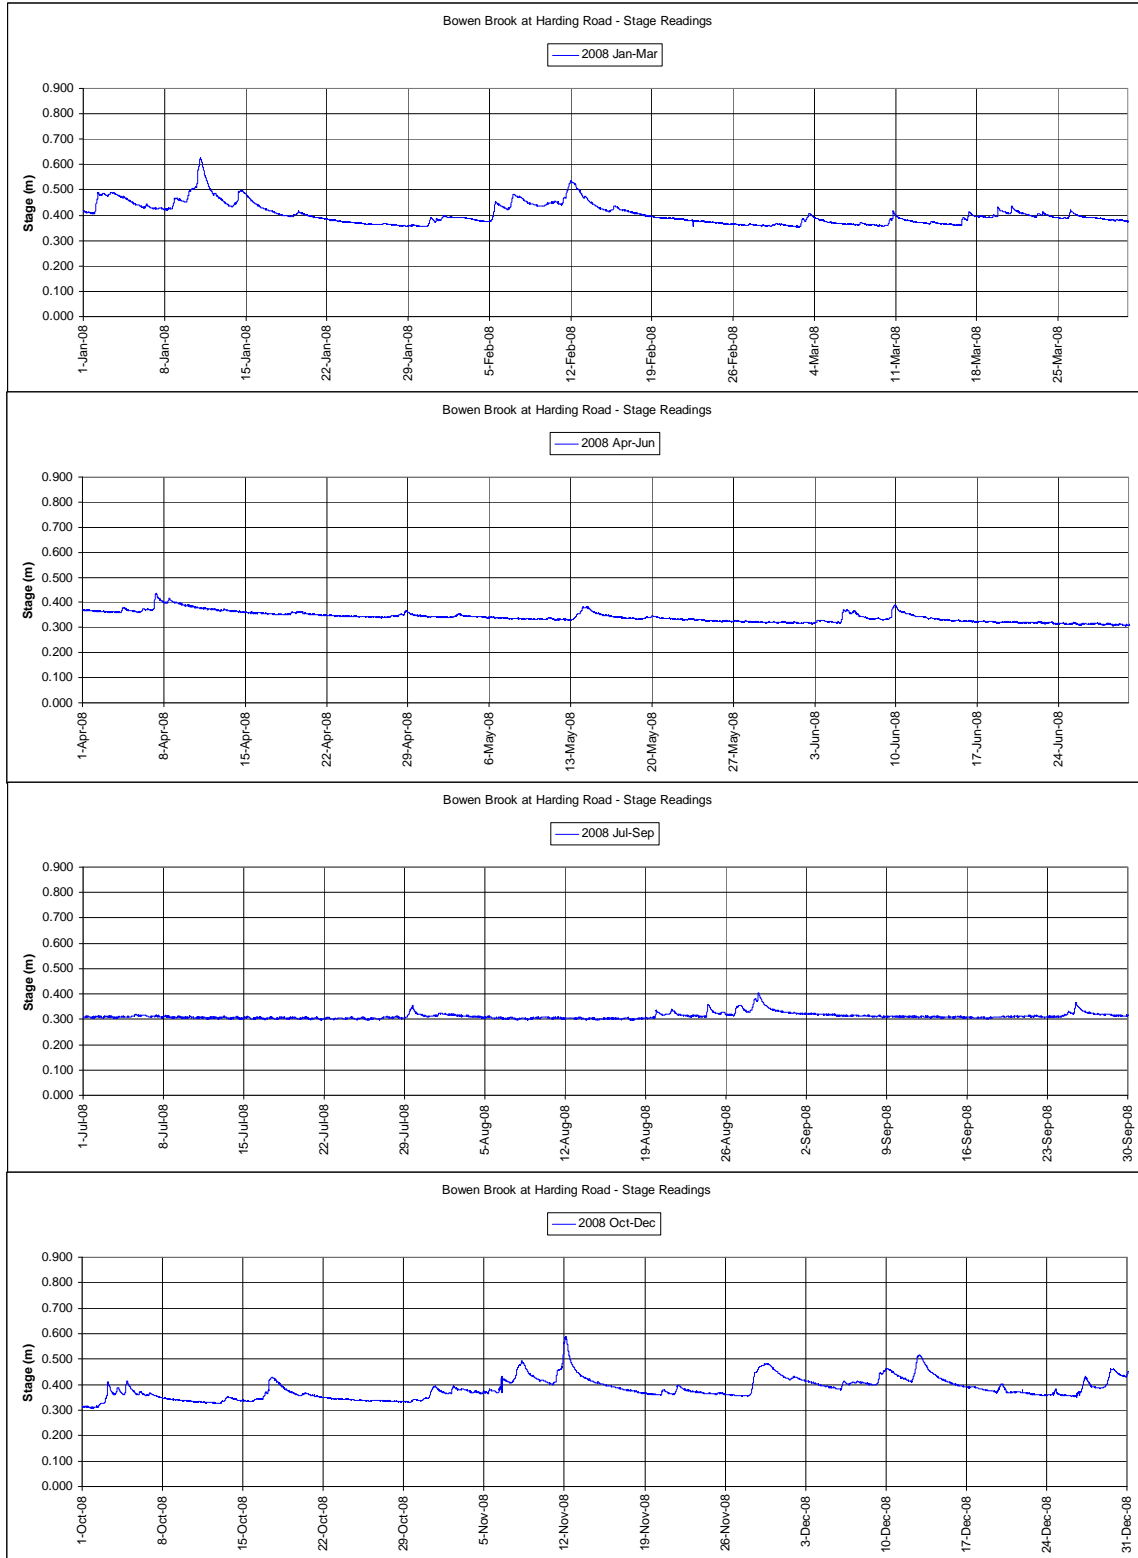
Graph 4-1. Water level (stage) in Bowen Brook at Harding Road during 2008.

Water losses through evaporation and evapotranspiration (ET) from vegetation in the summer were high enough to be detectable on a daily basis (for example, see Graph 4-1 July – September and Graph 4-2 June – August).⁵ The normal change in water level between the coolest and warmest time of day (i.e., before sunrise vs. mid- afternoon) reached ~10 cm in July and August as water inputs to the stream decreased due to daytime ET (Graphs 4-4 and 4-5). The change in water level was most pronounced during the warmest period of the day, when the rate of ET would have been highest.

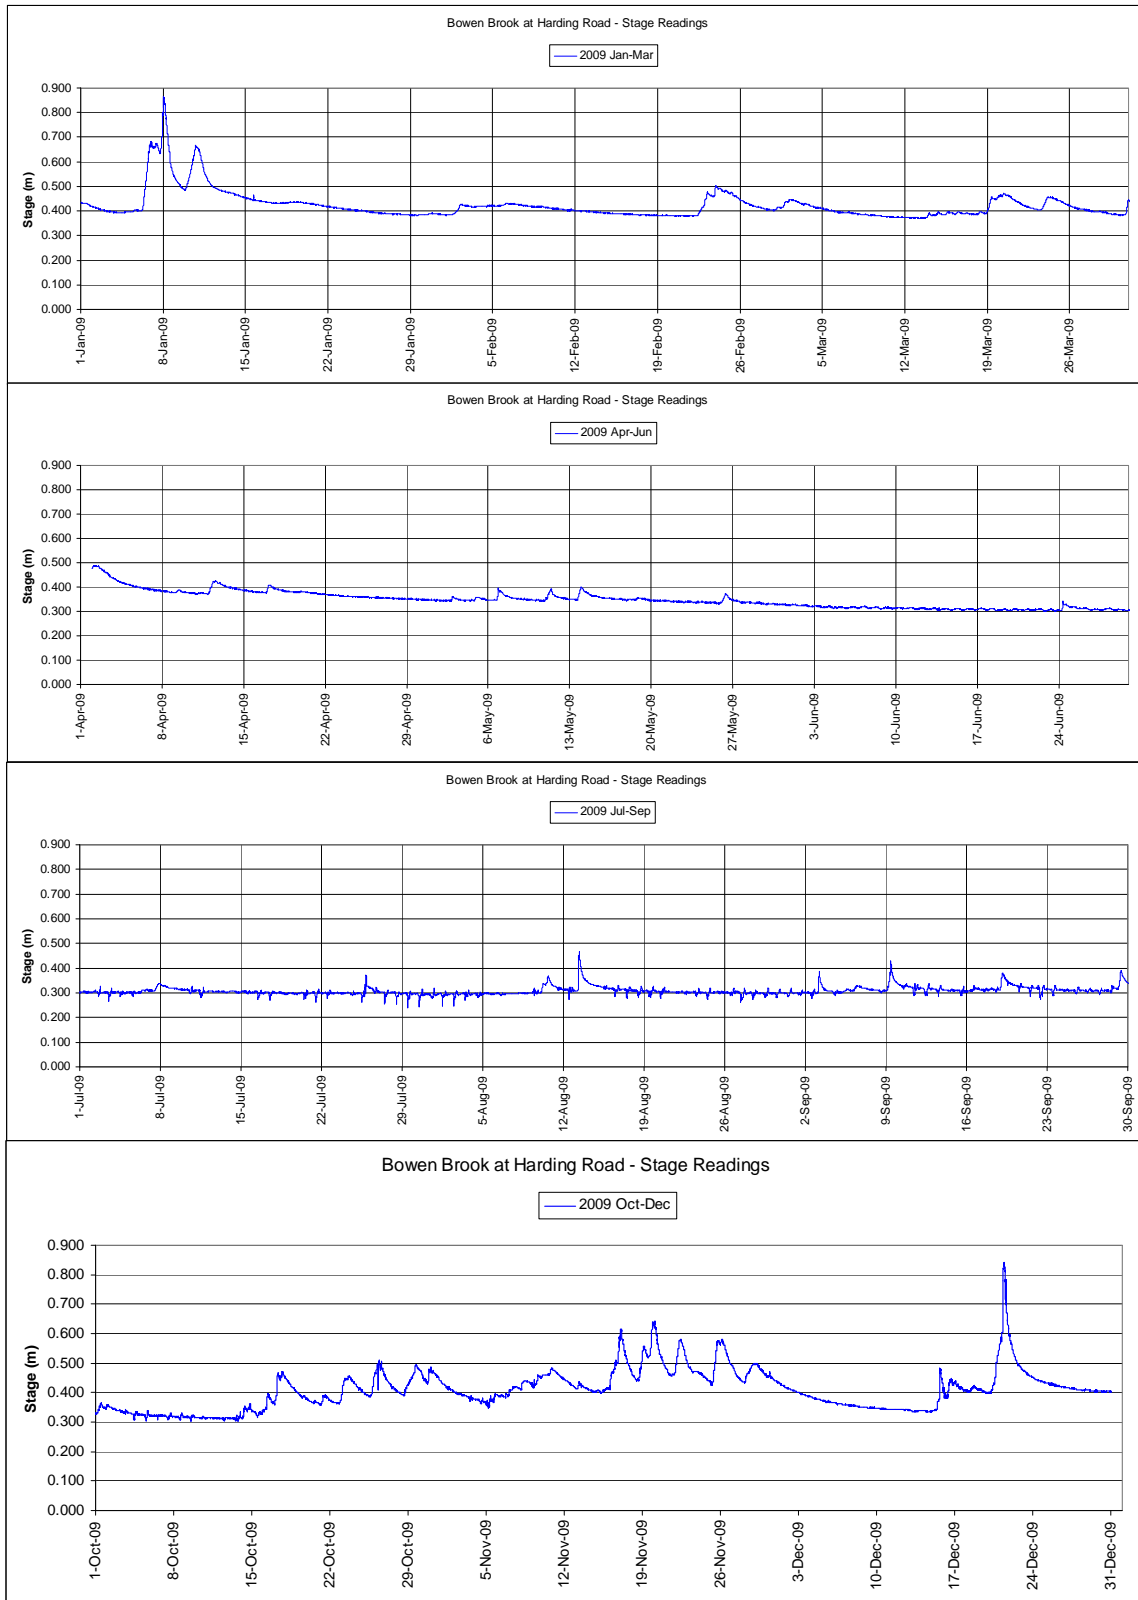
Graph 4-2. Water level (stage) in Bowen Brook at Harding Road during 2009.

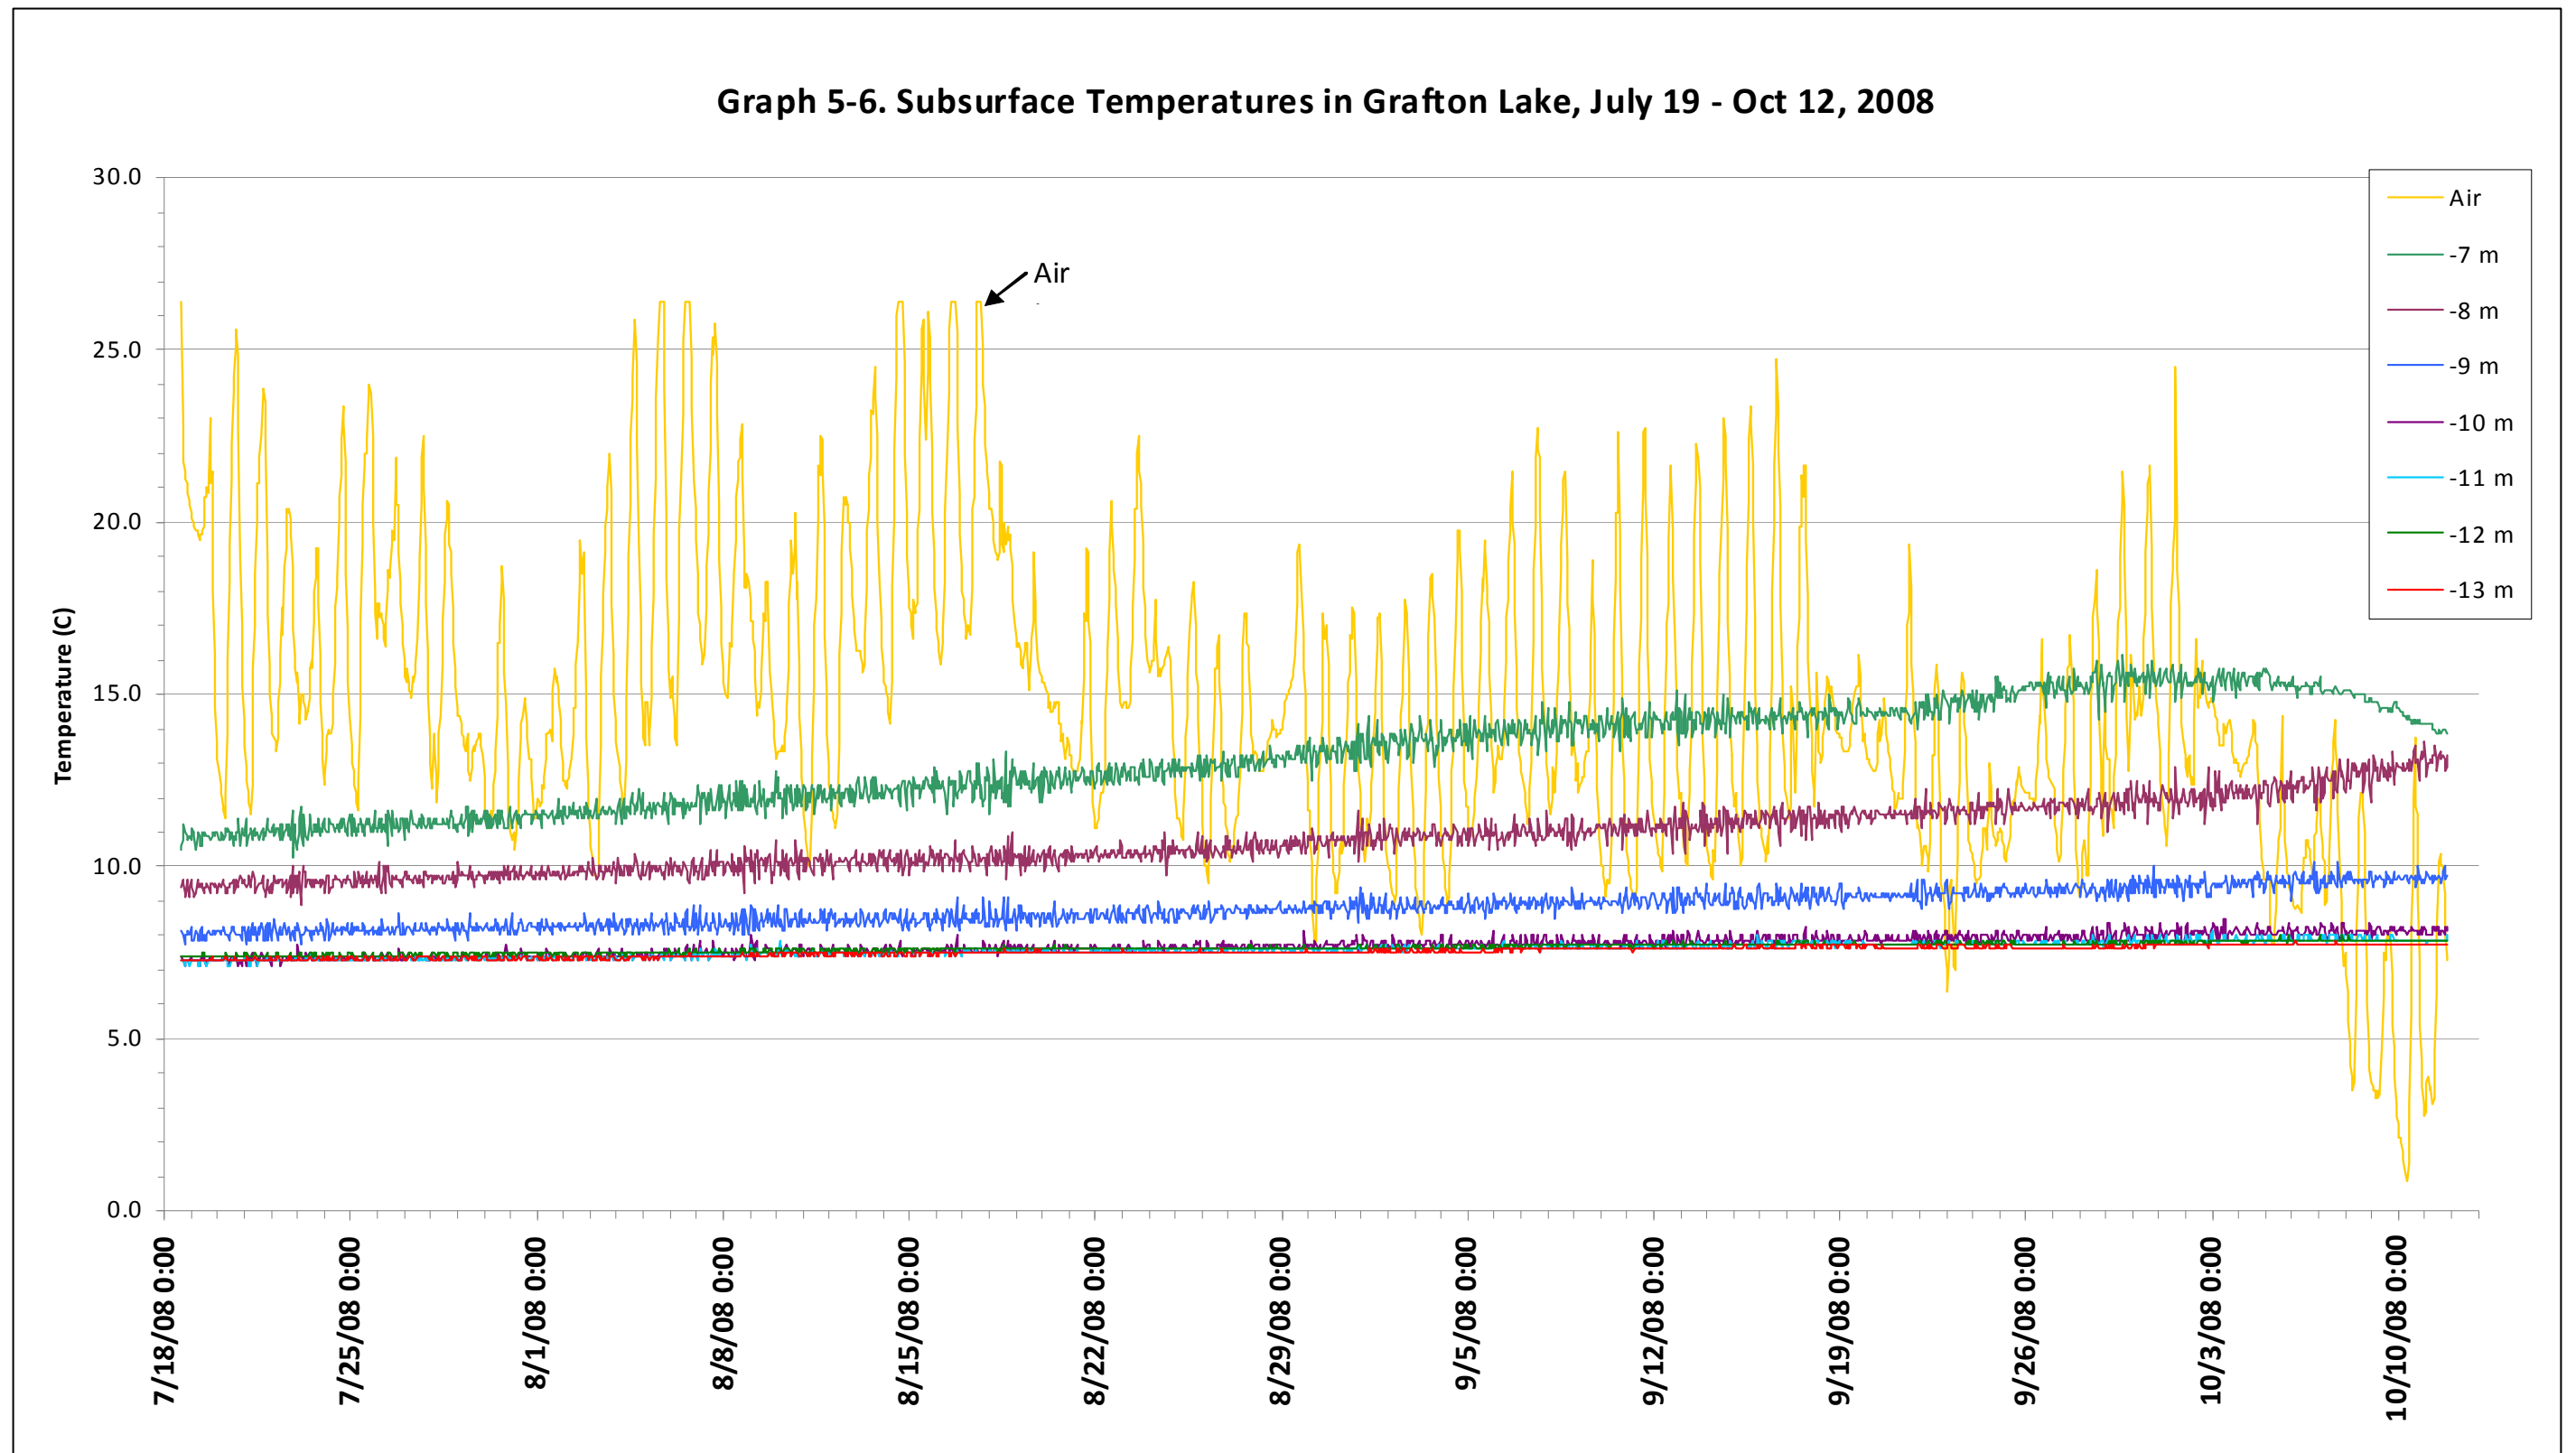
Graph 5-6. Subsurface Temperatures in Grafton Lake, July 19 - Oct 12, 2008

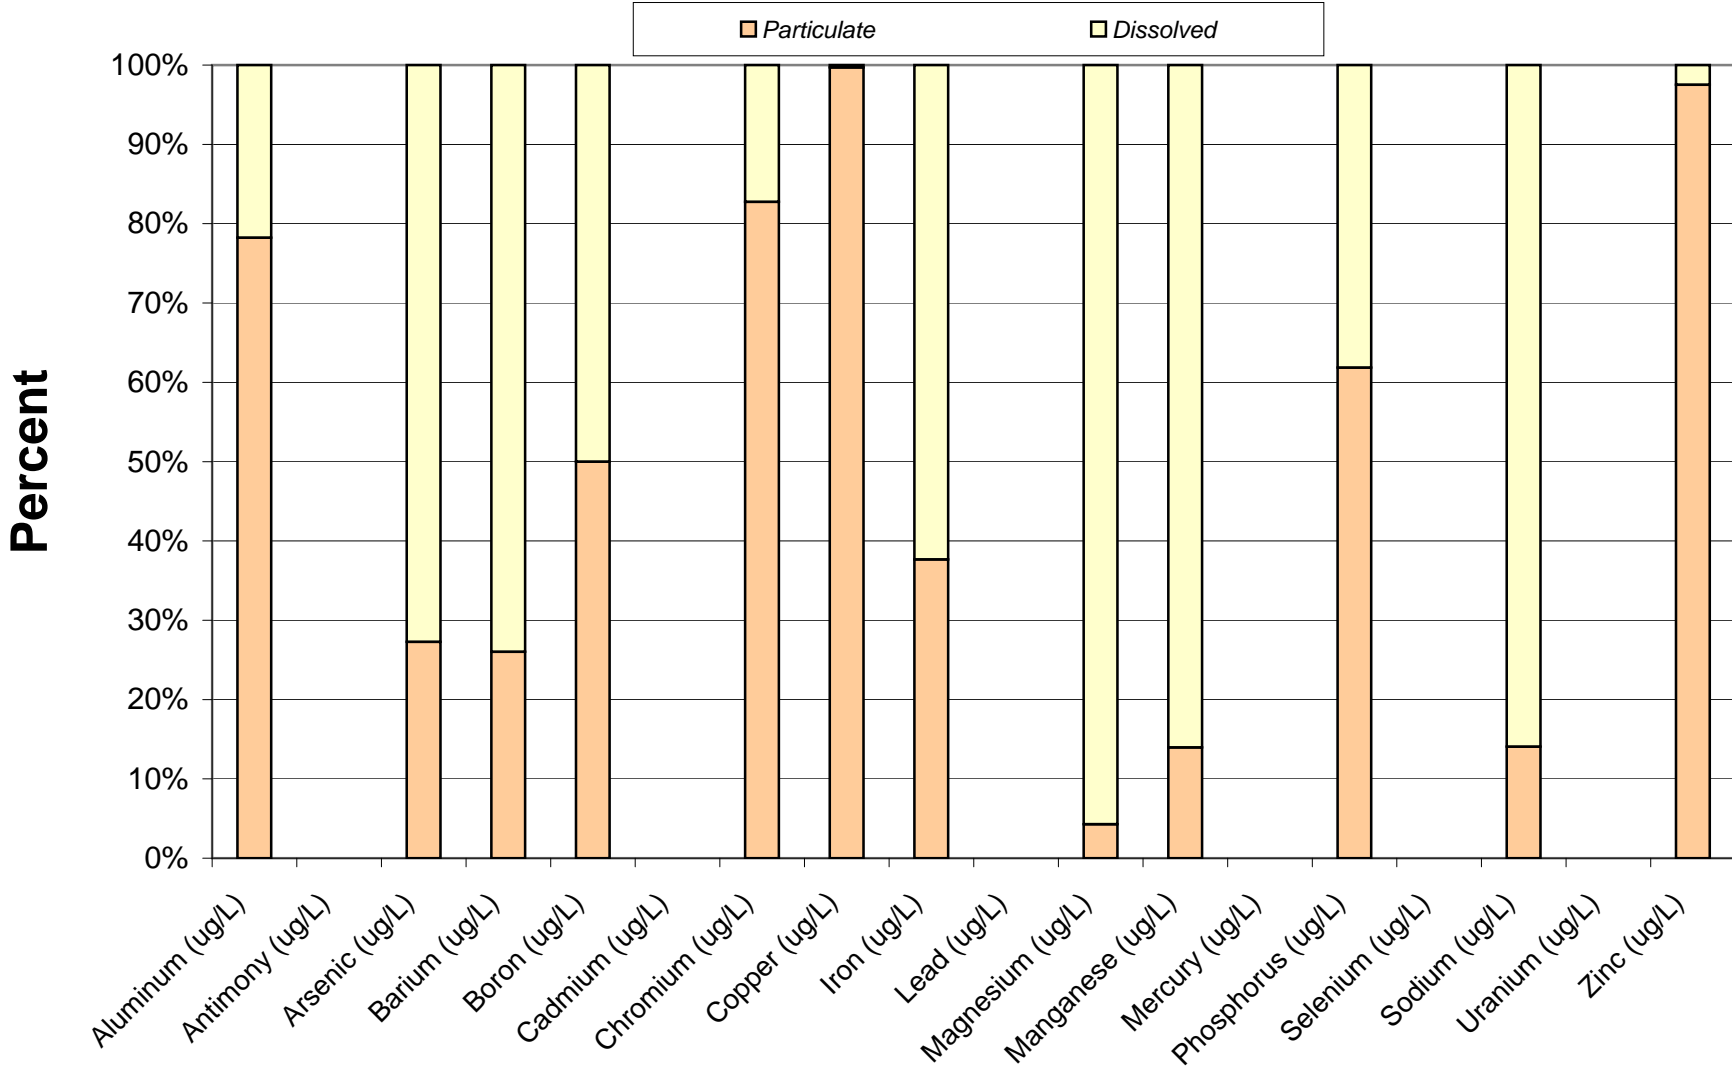
Graph B. Dissolved and Particulate Portions of Total Metals Content in Surface Water in Bowen Brook, 25 June 2008

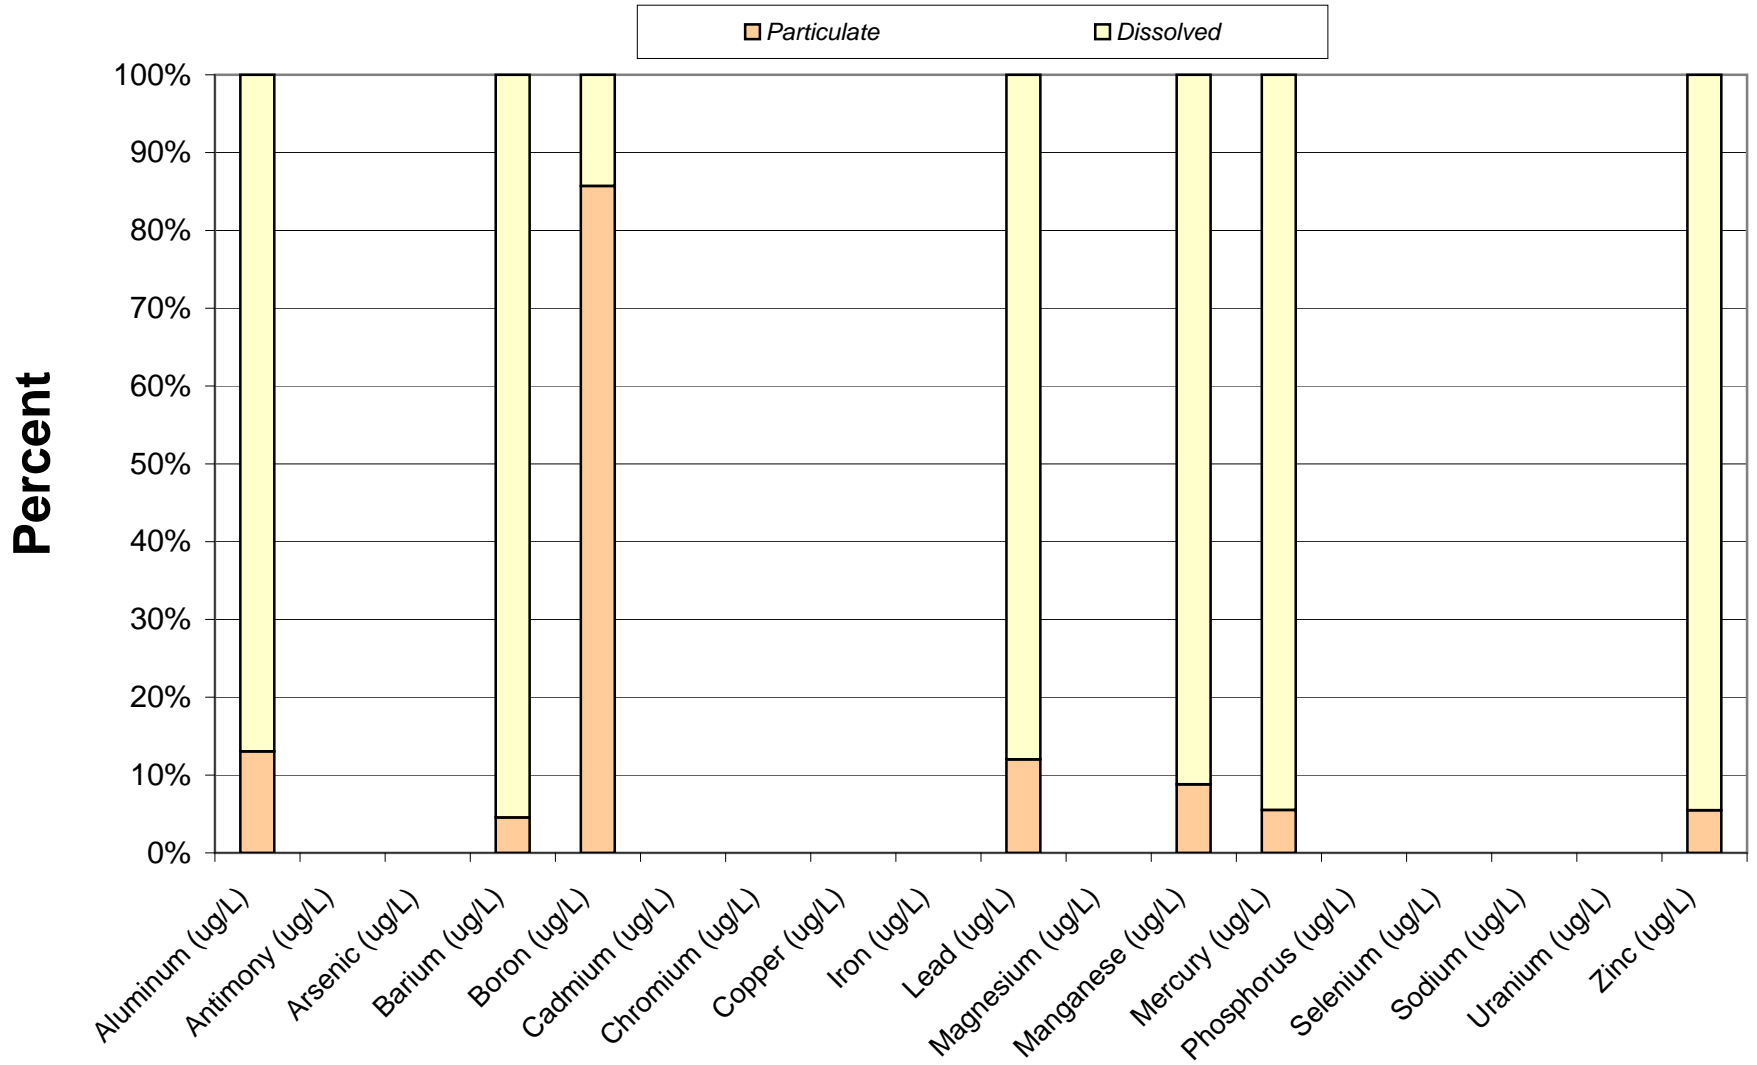
Graph C. Dissolved and Particulate Portions of Total Metals Content in Surface Water in Bowen Brook, 15 October 2008

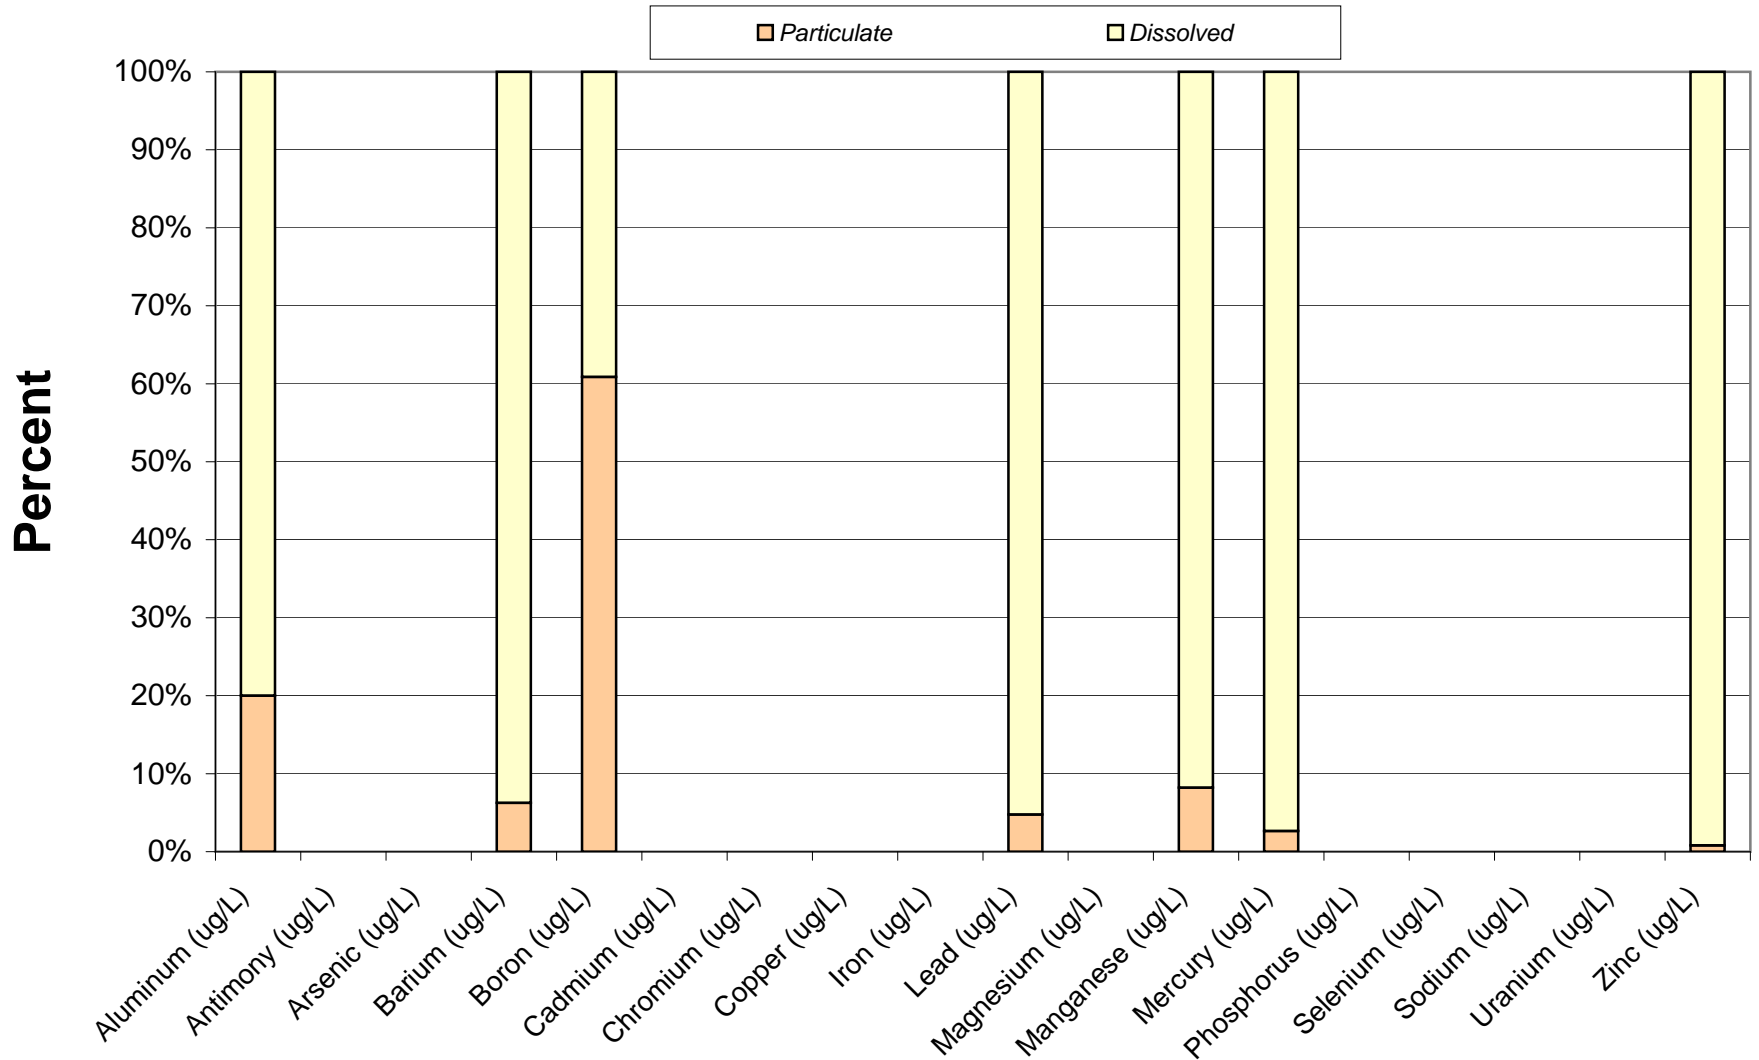
Graph D. Dissolved and Particulate Portions of Total Metals Content in Surface Water in Harding Brook, 22 August 2007

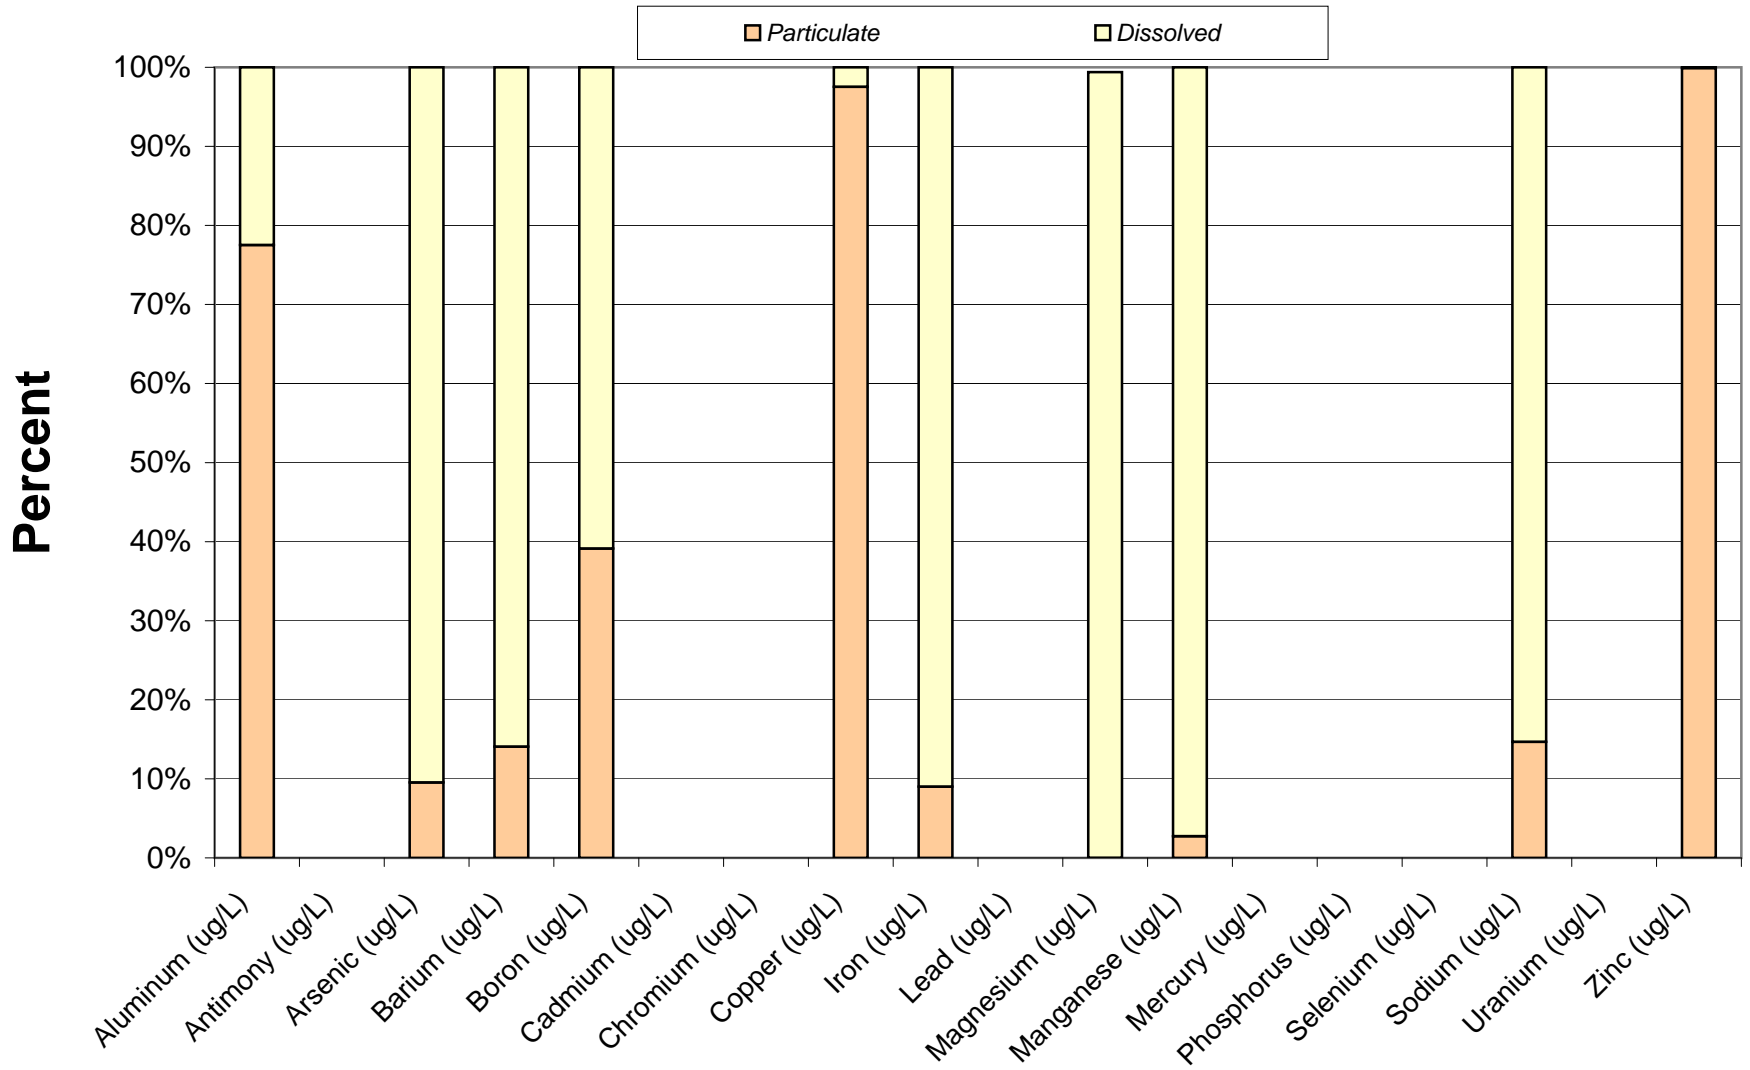
Graph E. Dissolved and Particulate Portions of Total Metals Content in Surface Water in Harding Brook, 25 June 2008

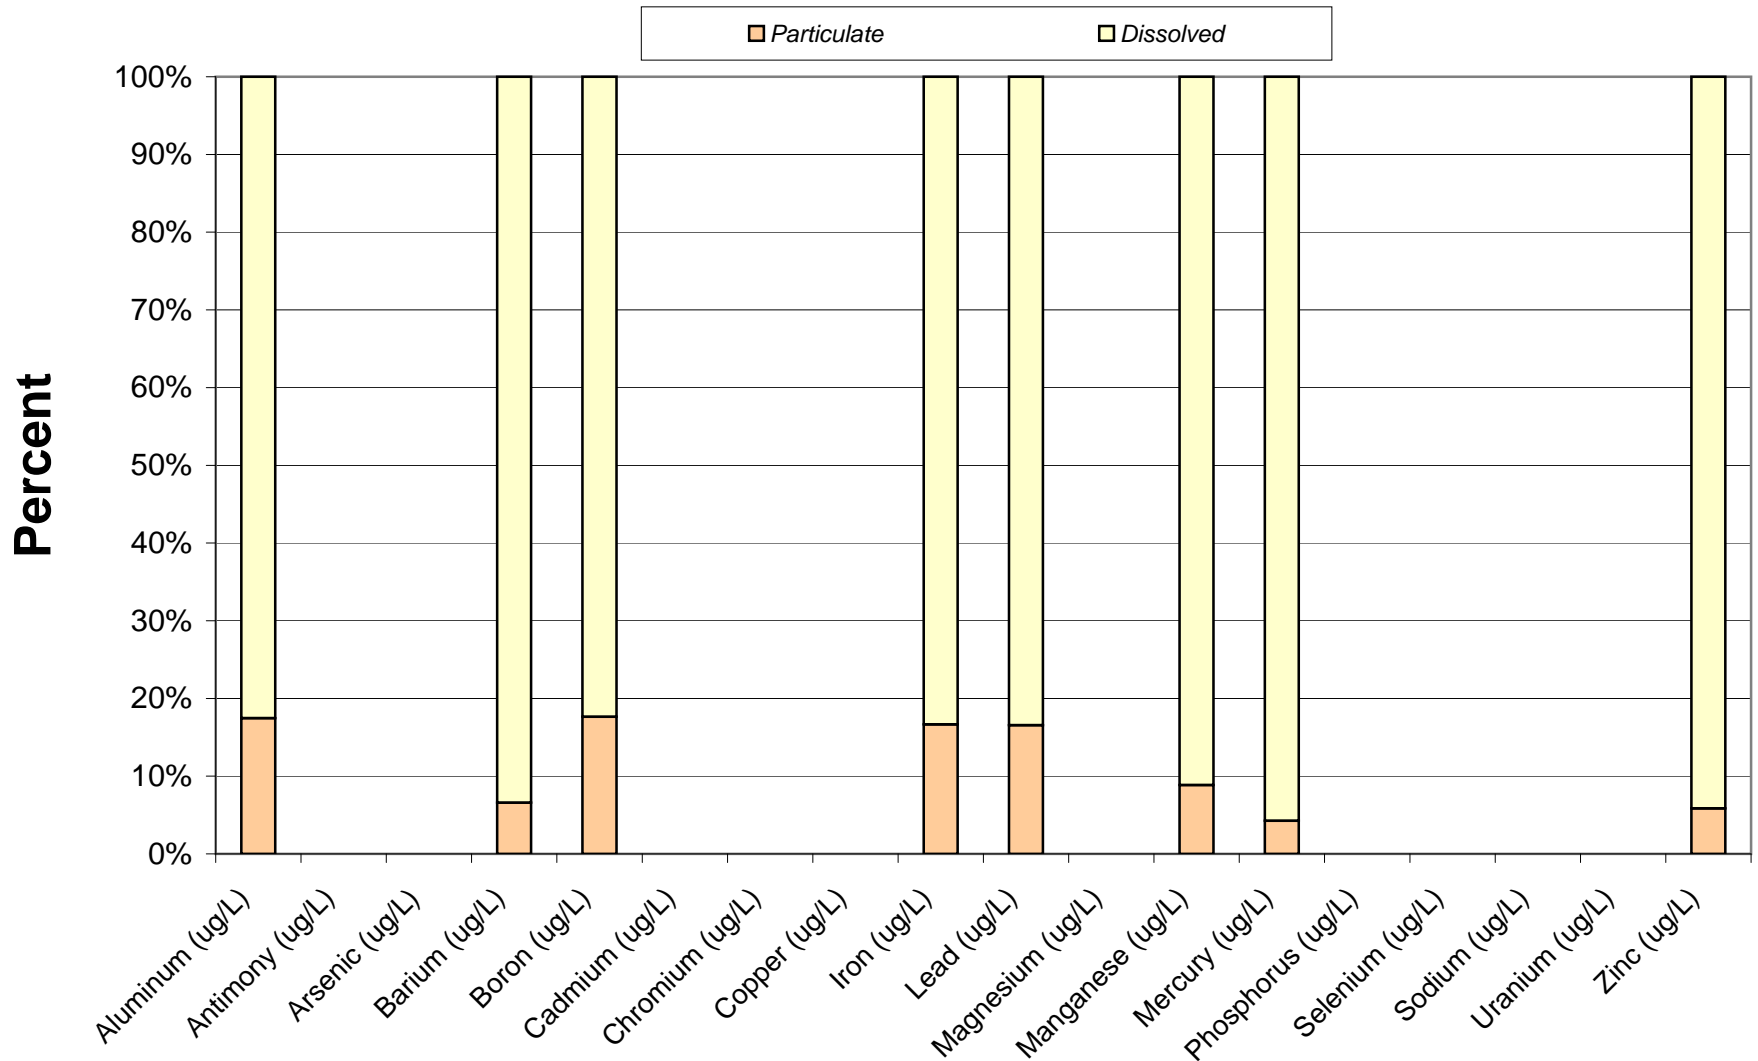
Graph F. Dissolved and Particulate Portions of Total Metals Content in Surface Water in Harding Brook, 15 October 2008

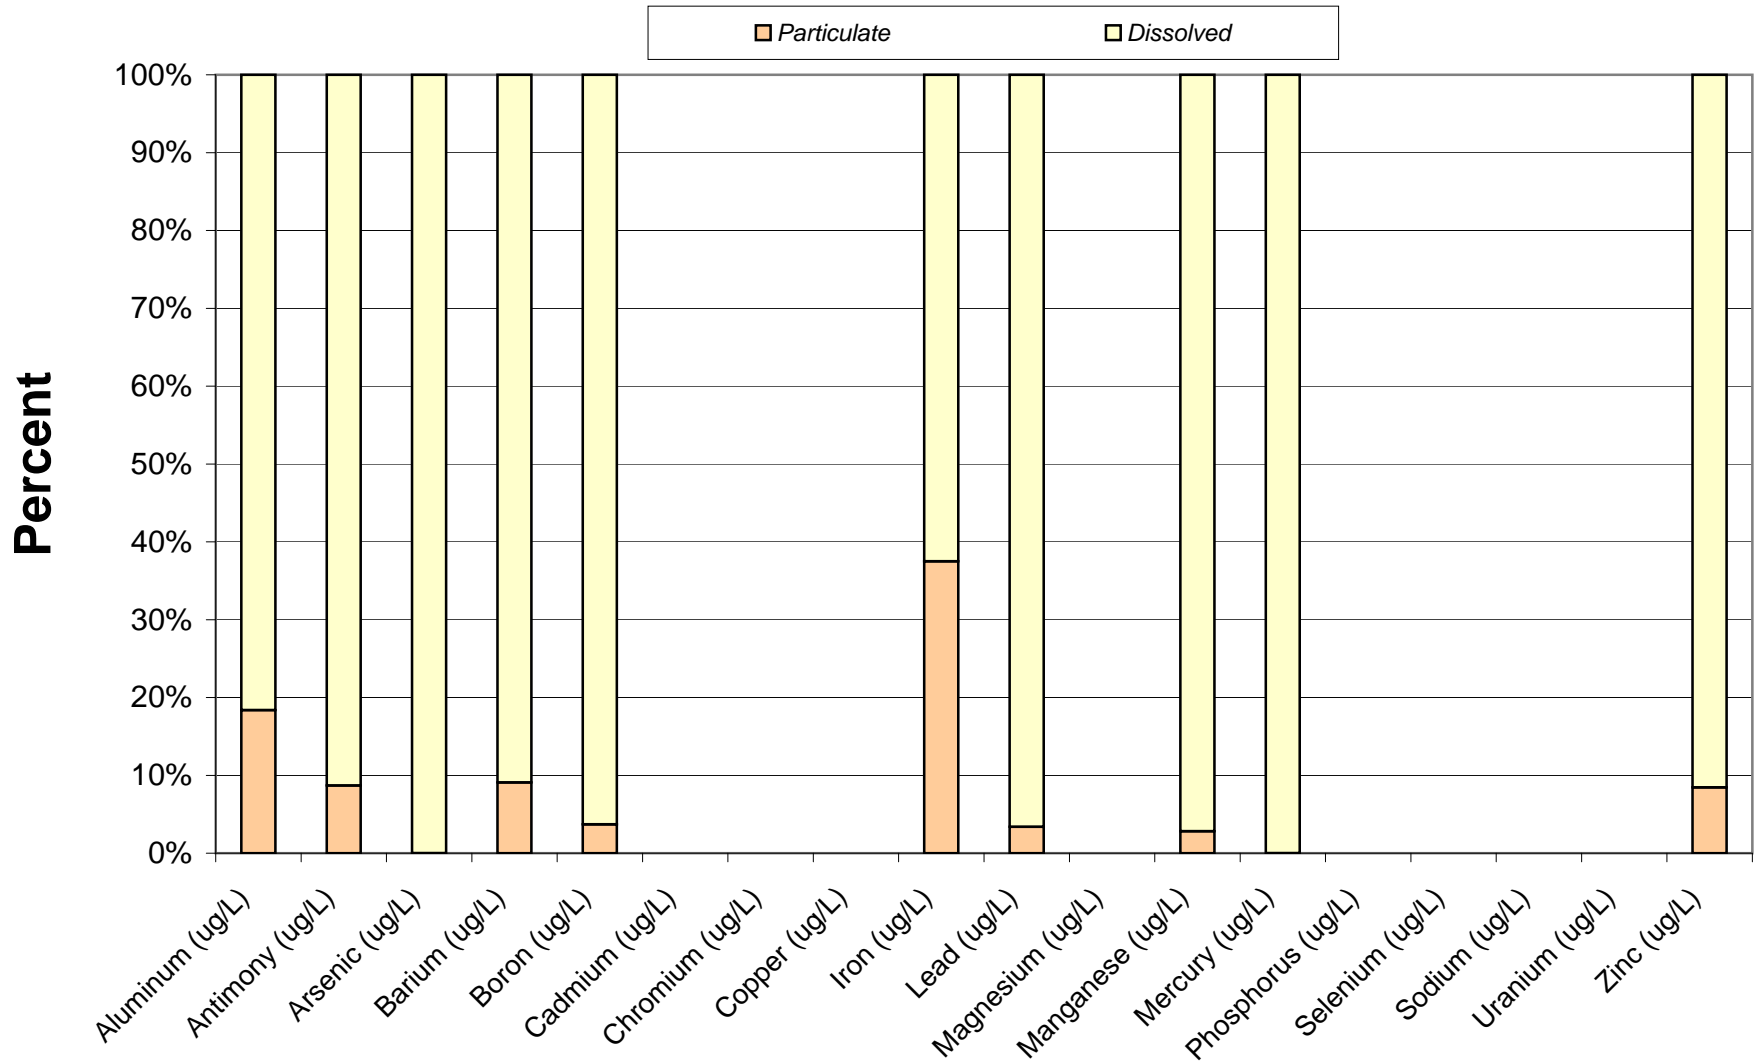
Graph G. Dissolved and Particulate Portions of Total Metals Content in Surface Water, Billington Creek, 22 August 2007

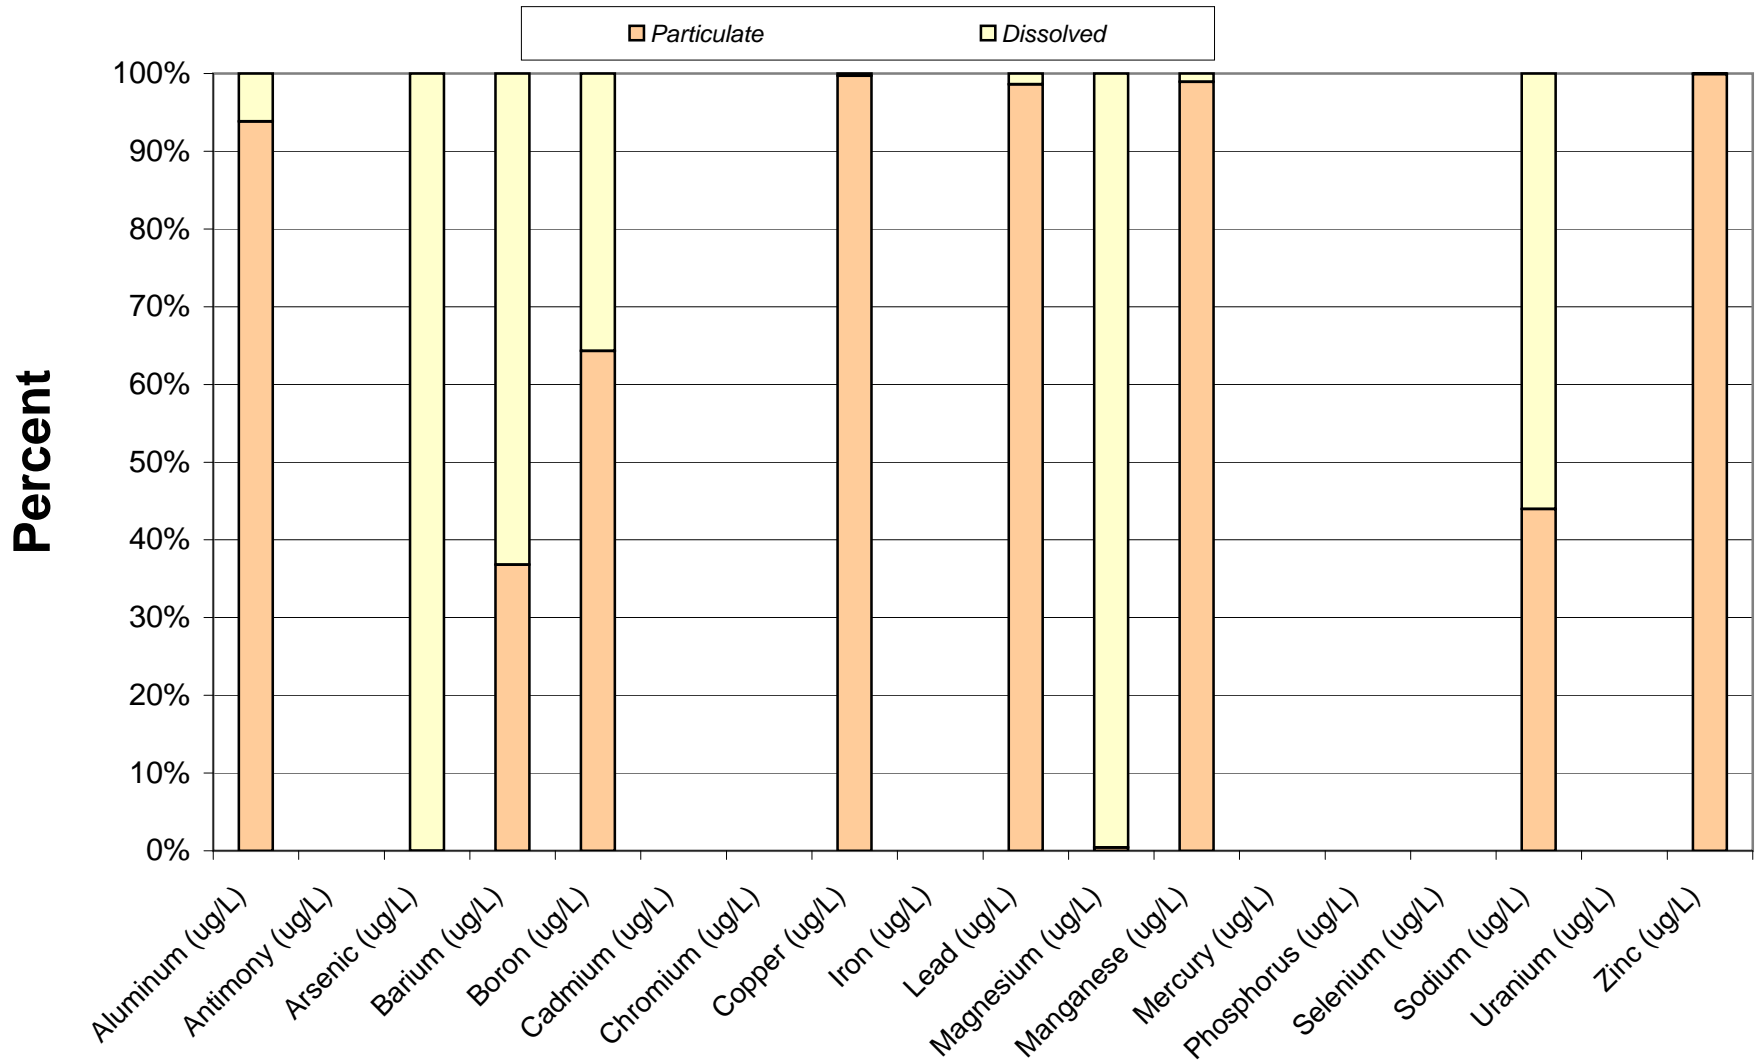
Graph H. Dissolved and Particulate Portions of Total Metals Content in Surface Water, Billington Creek, 25 June 2008
