Grafton Lake Watershed Study Report No. 2: 2007-2009

Bowen Island Municipality
(Cove Bay Water System)
981 Artisan Lane, Bowen Island, B.C.
V0N 1G0

Whitehead Environmental Consultants Ltd.
P.O. Box 41, Bowen Island, B.C.
V0N 1G0

February 2010

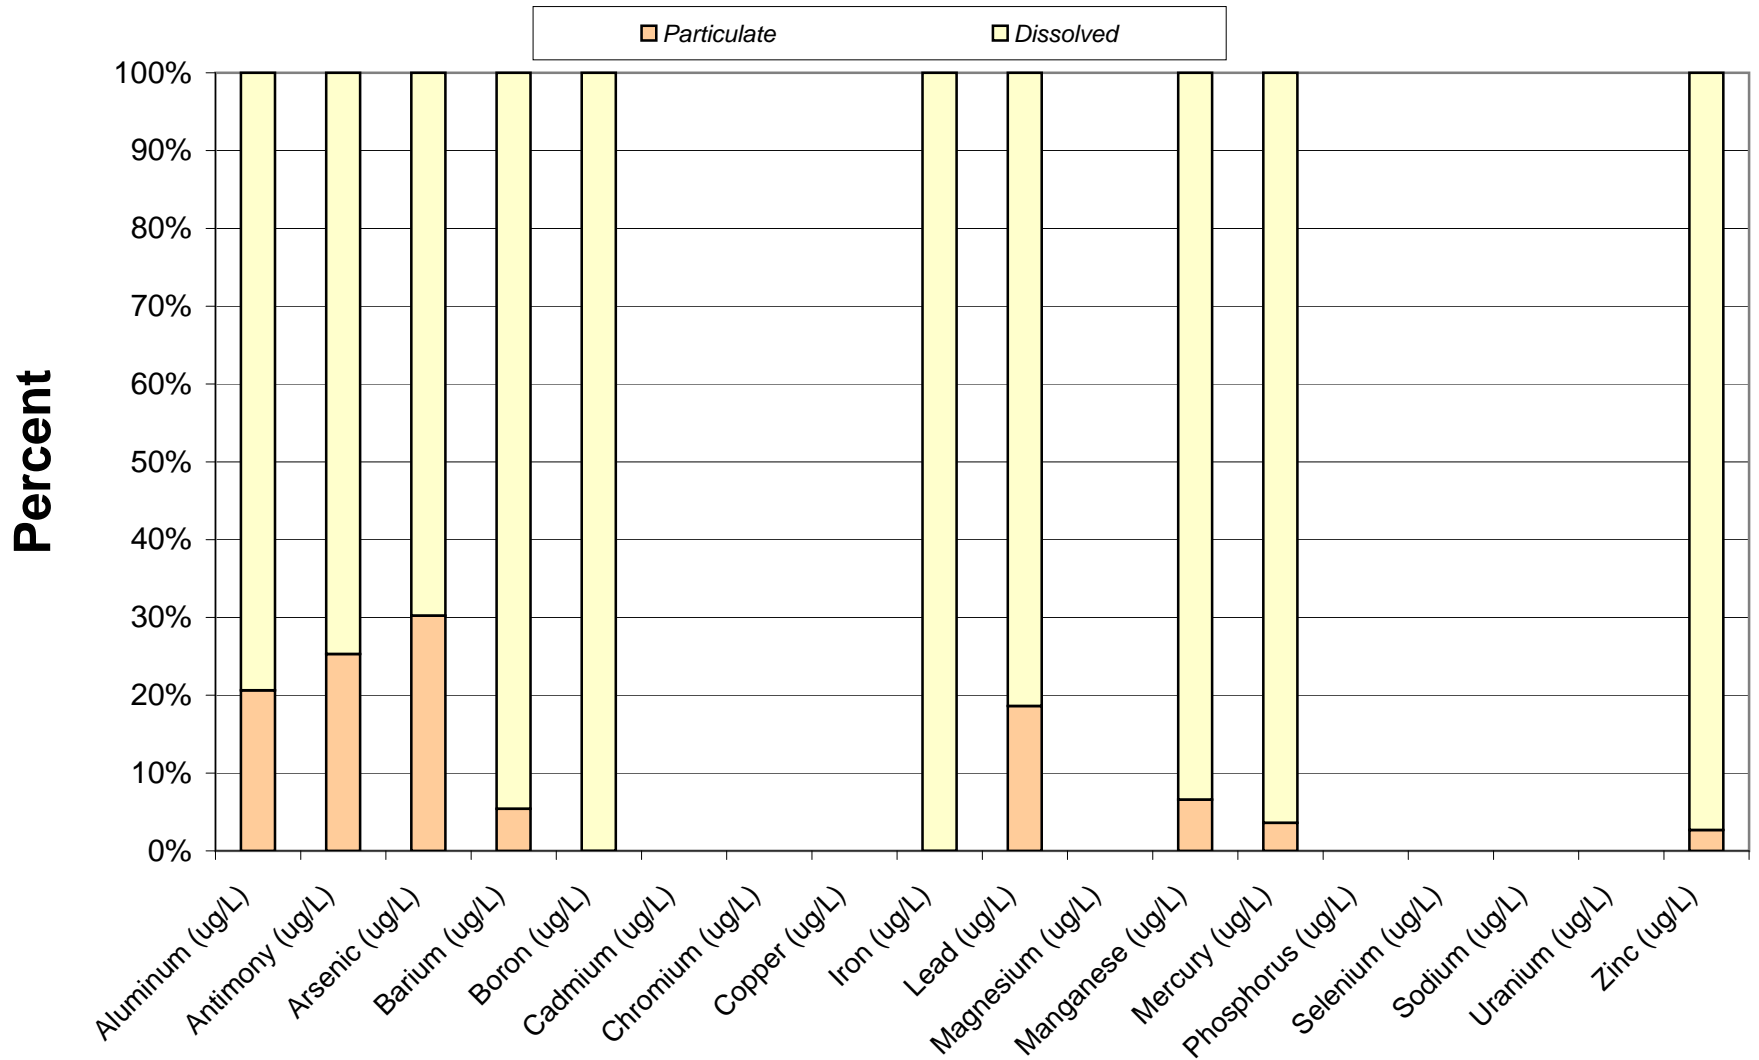
Graph I. Dissolved and Particulate Portions of Total Metals Content in Surface Water, Billington Creek, 15 October 2008

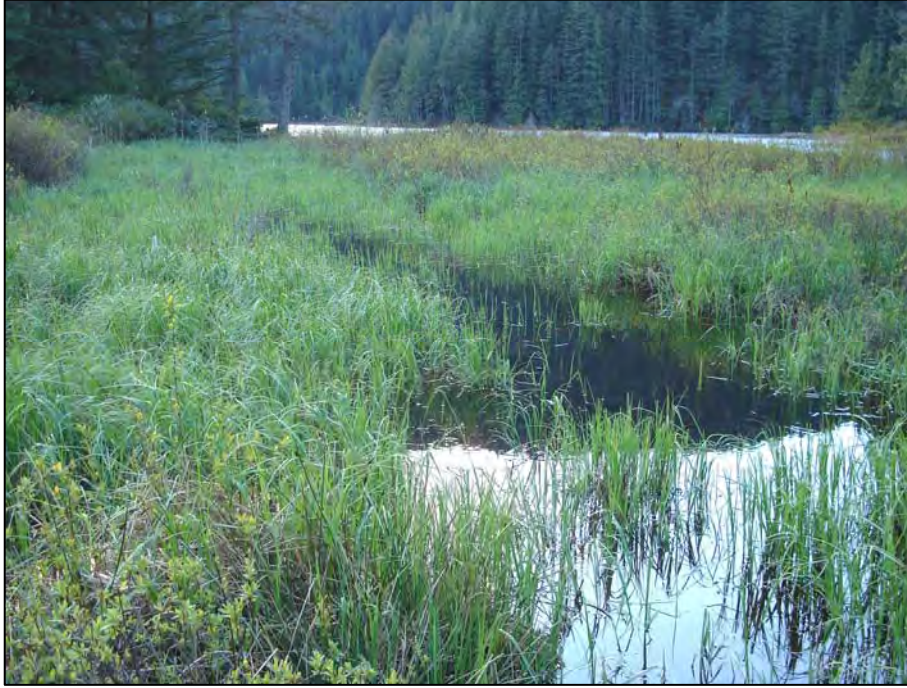
Photo 1. Marsh wetland at east end of Grafton Lake, viewed from vicinity of outlet dam. 8-May-07

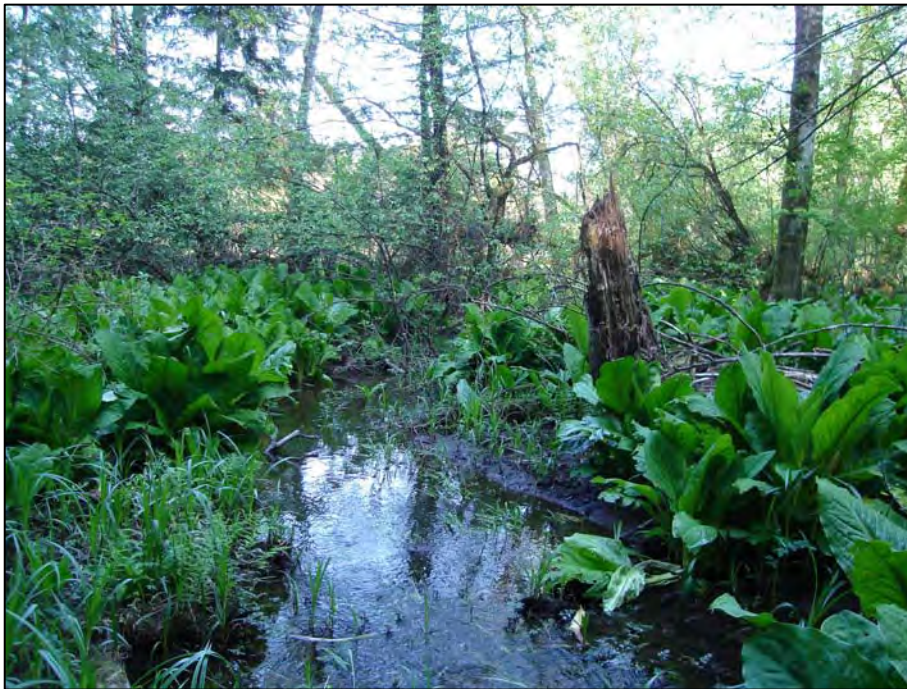
Photo 2. Swamp wetland in forest on west side of side Grafton Lake. 8-May-07

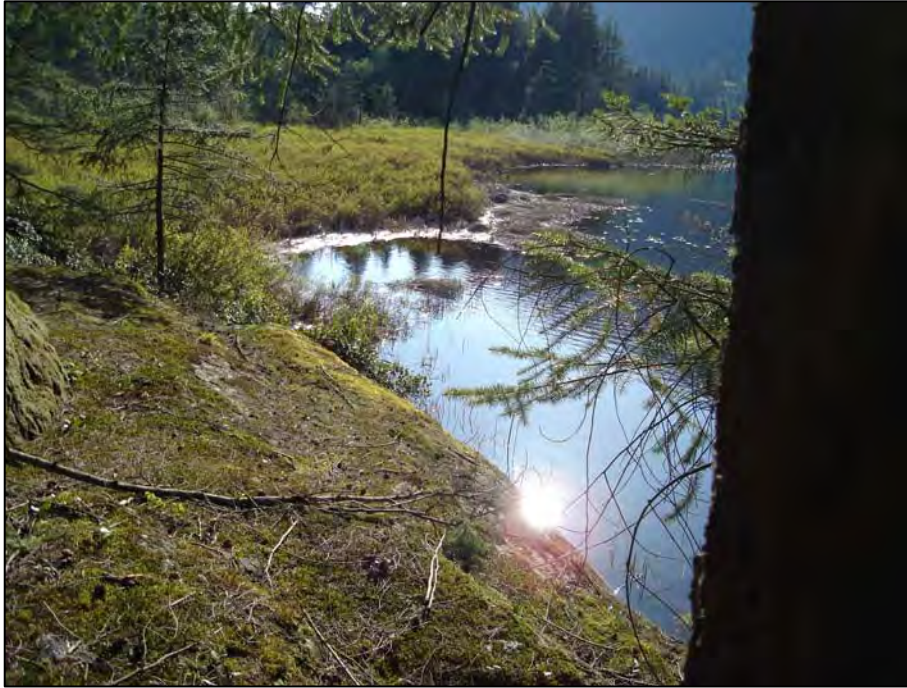
Photo 3. Marsh on northeast side of Grafton lake viewed from cliff on north side.
11-May-07

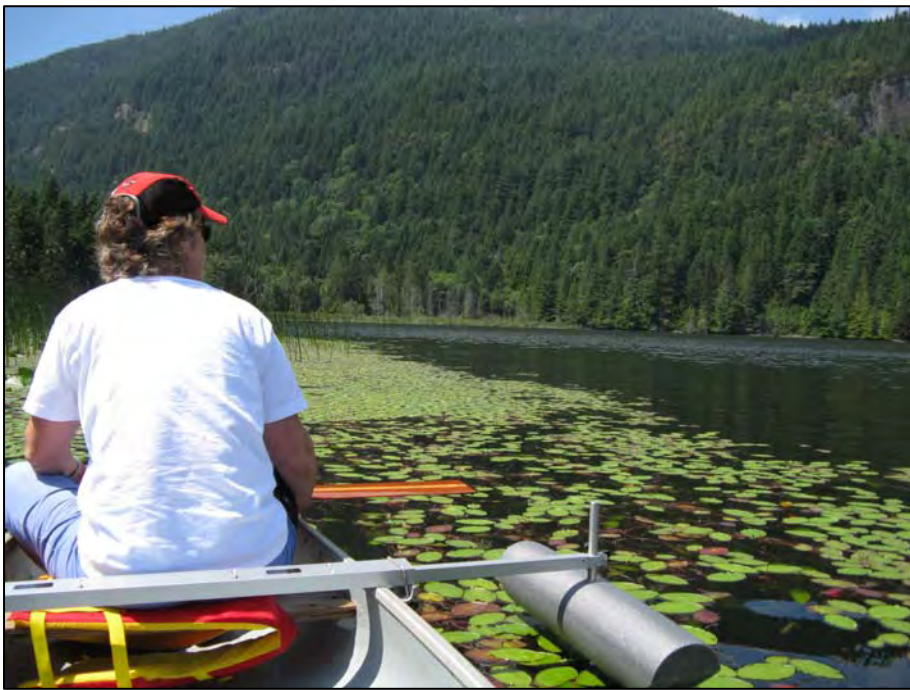
Photo 4. Outer edge of marsh on southwest side of Grafton lake, viewed to north.
18-Jul-08

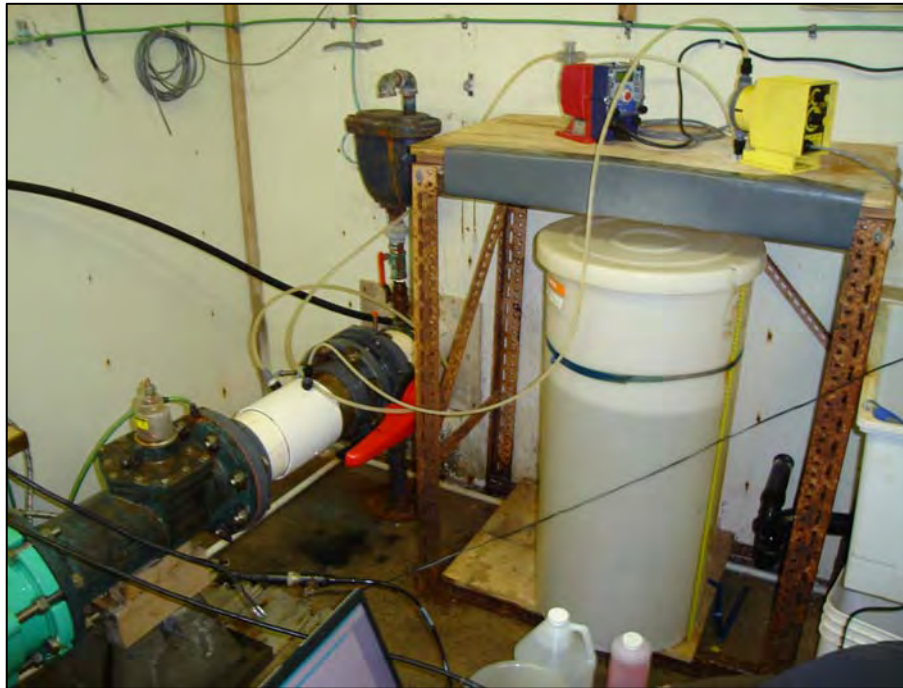
Photo 5. Automated water quality monitoring apparatus in CBWS chlorination shed, operated by Ministry of Environment Water Stewardship. 17-Jul-07

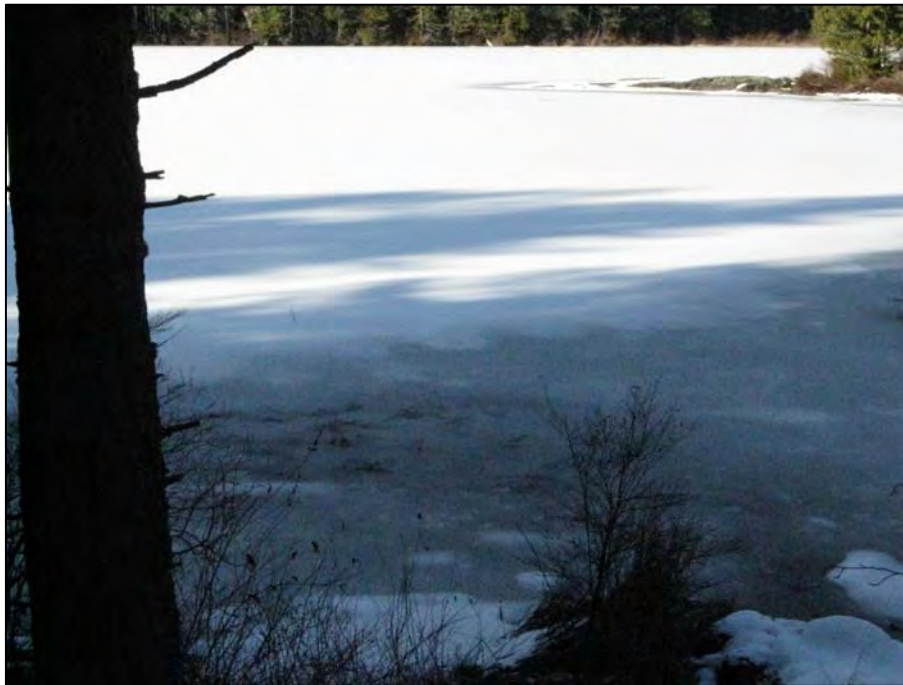
Photo 6. Snow and ice cover on Grafton lake, viewed from south side toward rocky point. 11-Feb-09

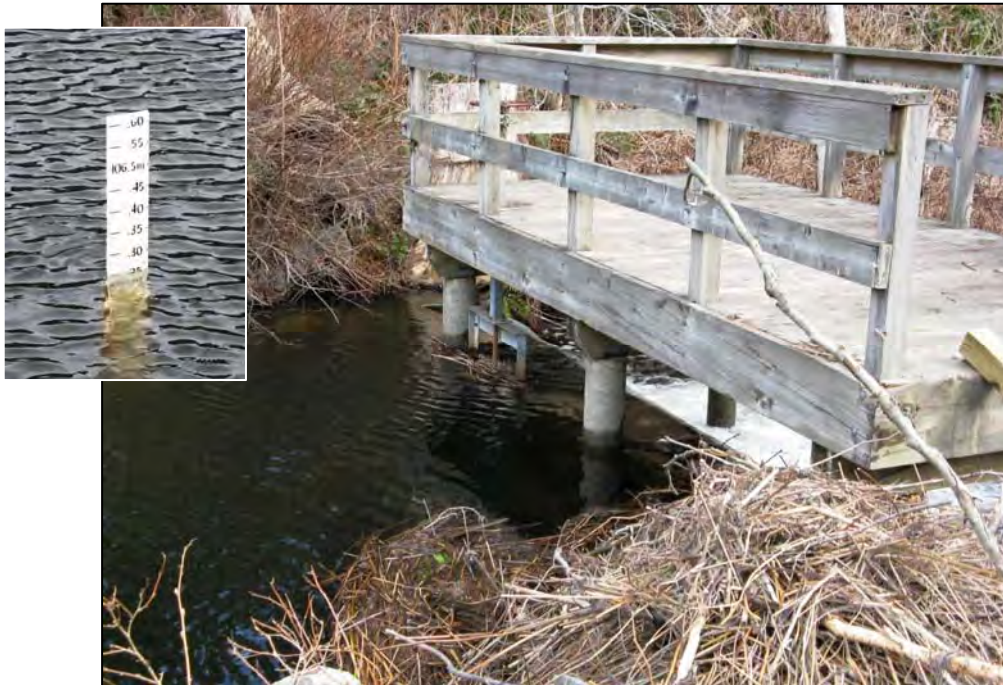
Photo 7. Outlet dam on Grafton lake and beaver dam debris removed by BIM staff. Inset shows water level of 105.20 m on that date. 25-Mar-09

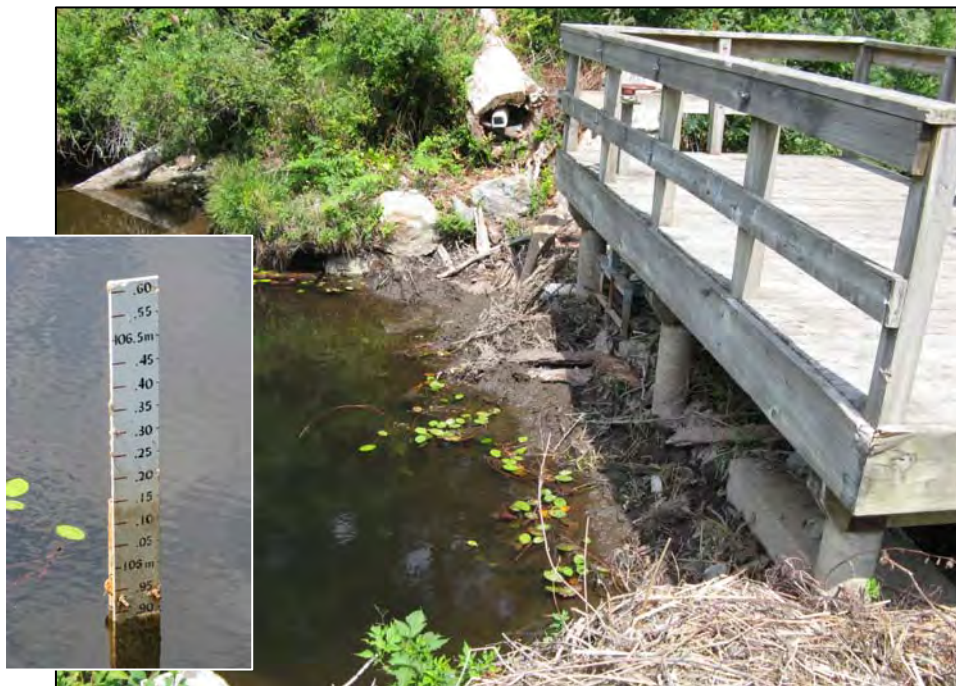
Photo 8. Grafton lake outlet dam during summer draw-down. Inset shows staff gauge indicating a water level of 104.87 m on that date. Note remote-control video camera in log on far side of dam, used to monitor beaver activity. 23-Jul-09

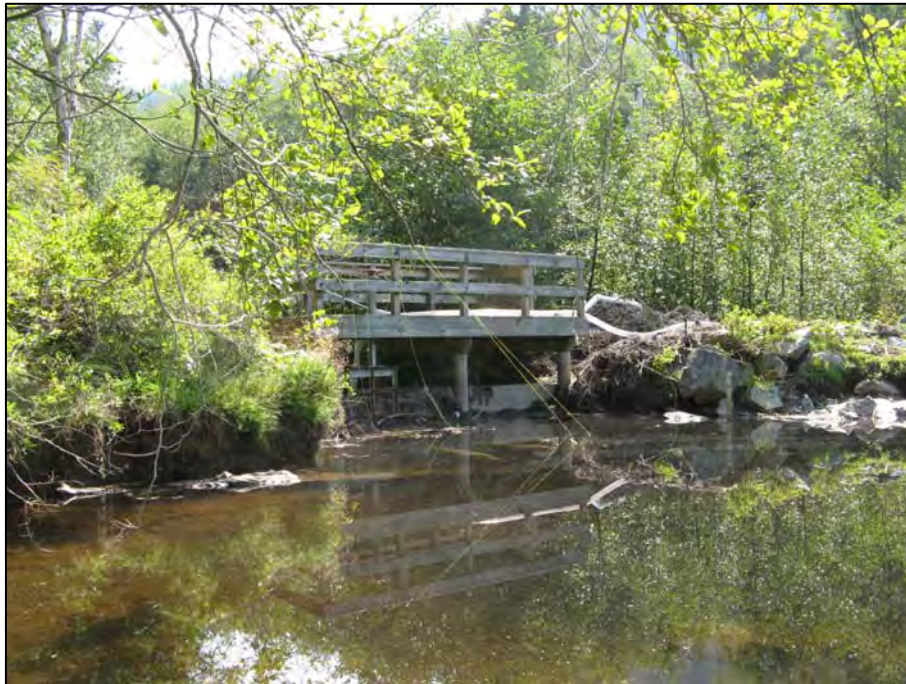
Photo 9. Grafton lake outlet dam during summer draw-down. Ropes attach to outlet pipes installed through under drain to overcome damming by beavers and ensure compliance with water release requirements to Terminal Creek. 19-Aug-09

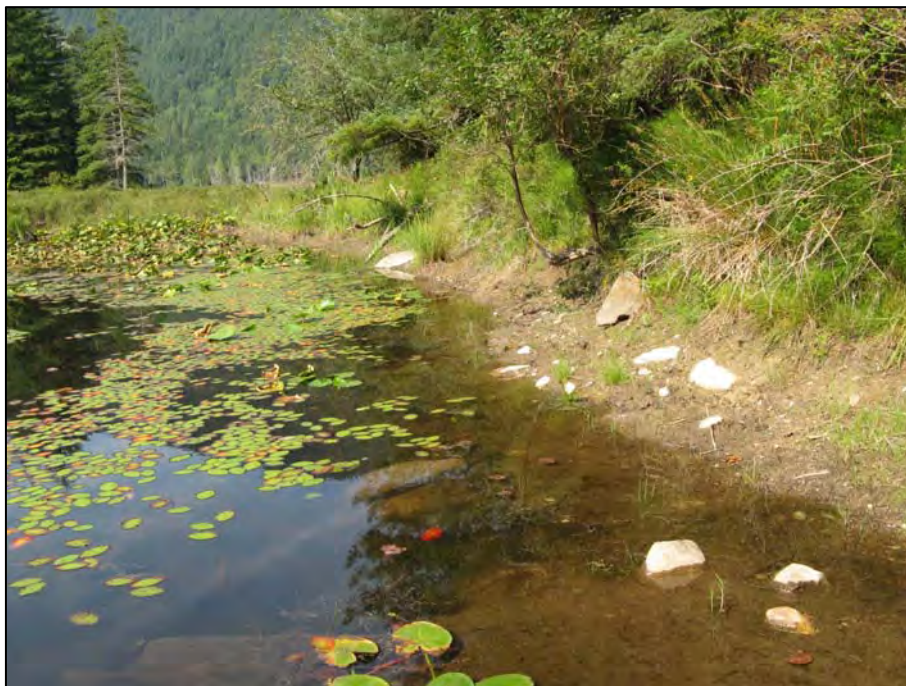
Photo 10. Lake bed in marsh at east end of Grafton Lake exposed by water draw down in summer. 19-Aug-09

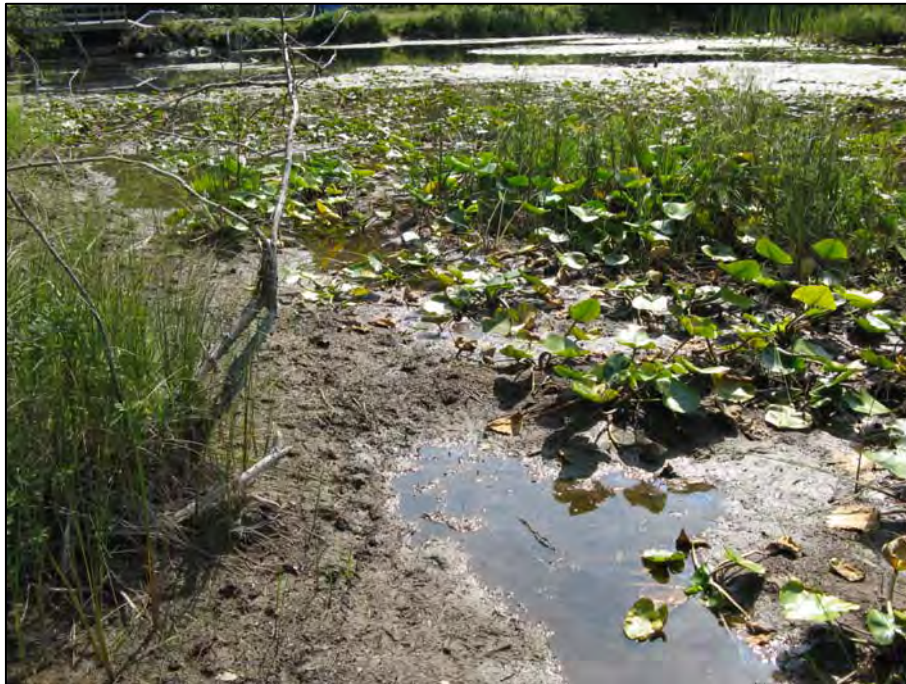
Photo 11. Marsh sediments at east end of Grafton Lake exposed by water draw down in summer. Oxidation of nitrogen in these sediments during exposure to air causes release of nitrate into water once sediments become re-submerged. 19-Aug-09

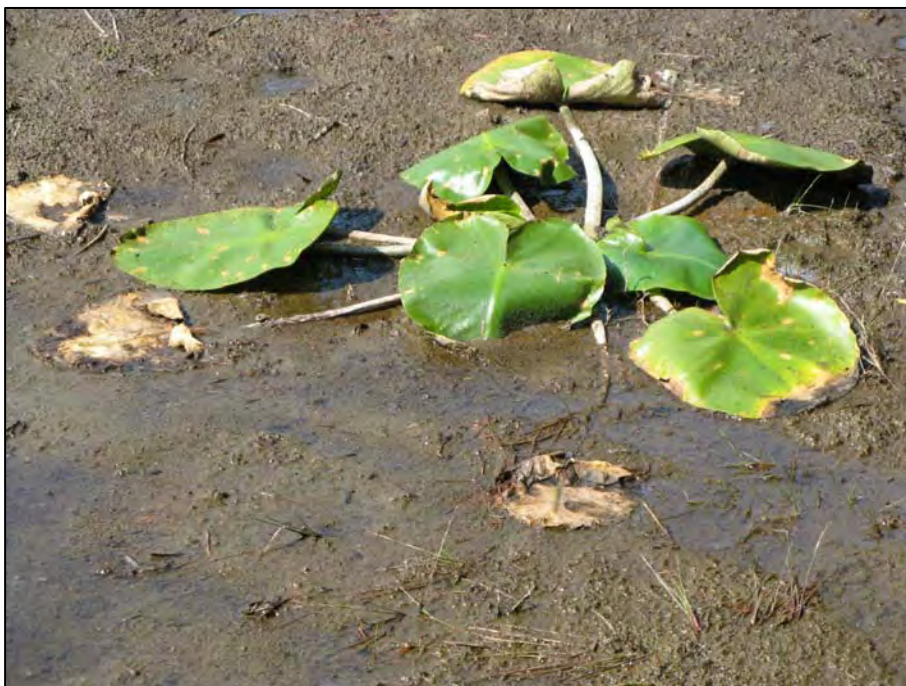
Photo 12. Yellow pond lily plant exposed to overheating during lake draw of Grafton Lake reservoir down in summer. 19-Aug-09

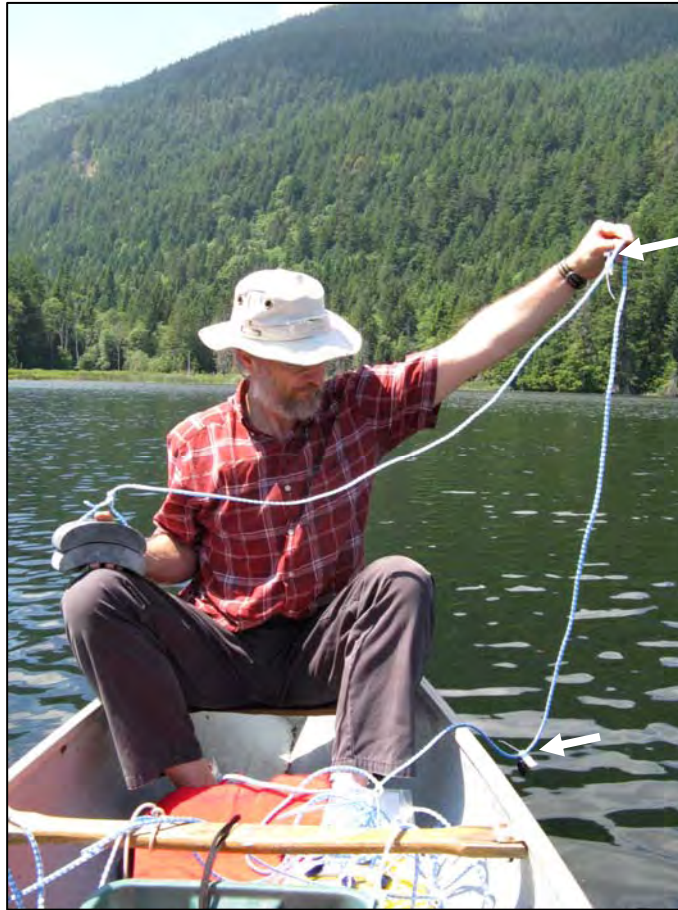
Photo 13. Deployment of recording temperature sensors in Grafton Lake. Arrows indicate individual sensors spaced at 1-m depth intervals. 18-Jul-08

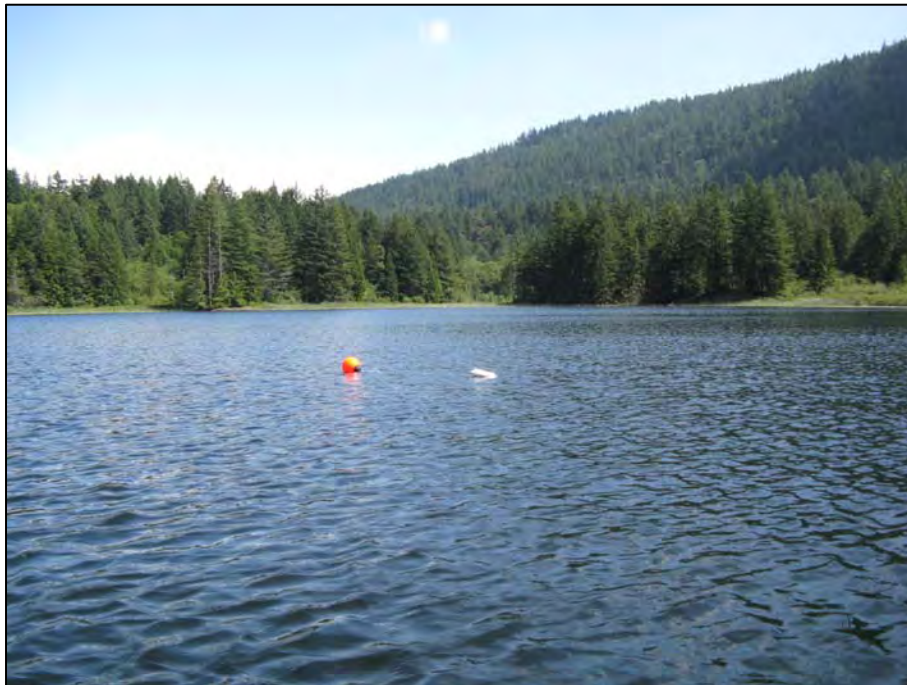
Photo 14. Buoys marking location of temperature monitoring system in Grafton Lake, viewed toward outlet dam. 18-Jul-08

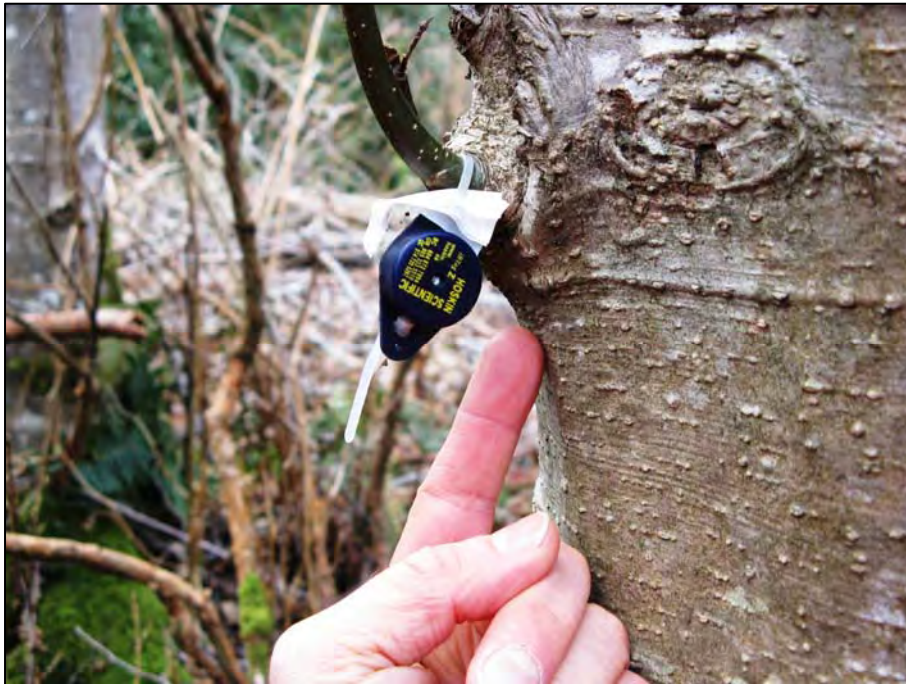
Photo 15. Close-up of temperature monitoring device (battery-powered thermister and data logger) installed to measure air temperature beside Grafton lake. 25-Mar-09

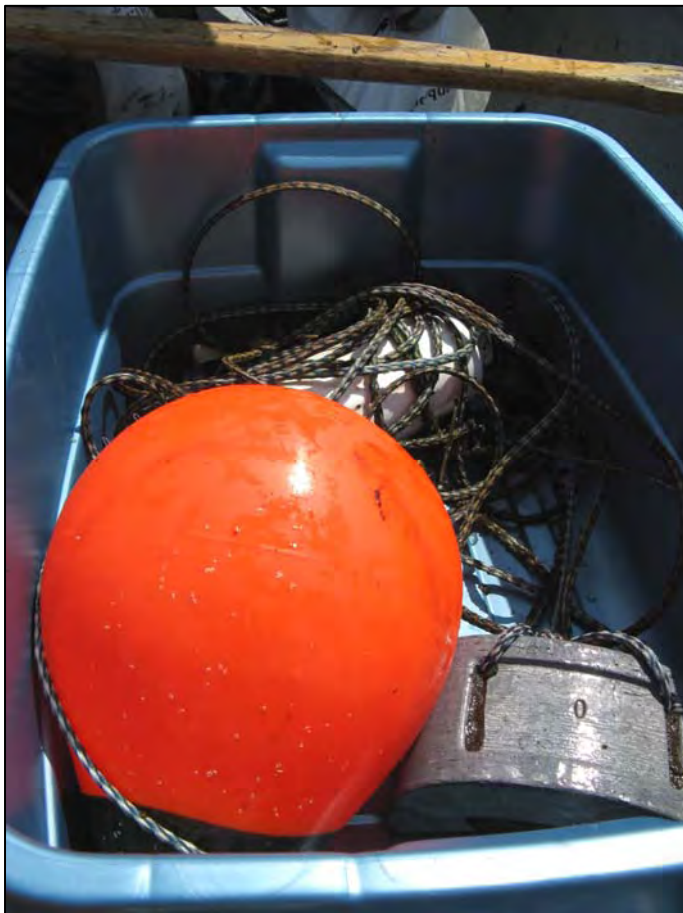
Photo 16. Water temperature monitoring system after retrieval from Grafton Lake. Photo shows anchor, floats and rope on which temperature sensors were attached. 23-Jul-09

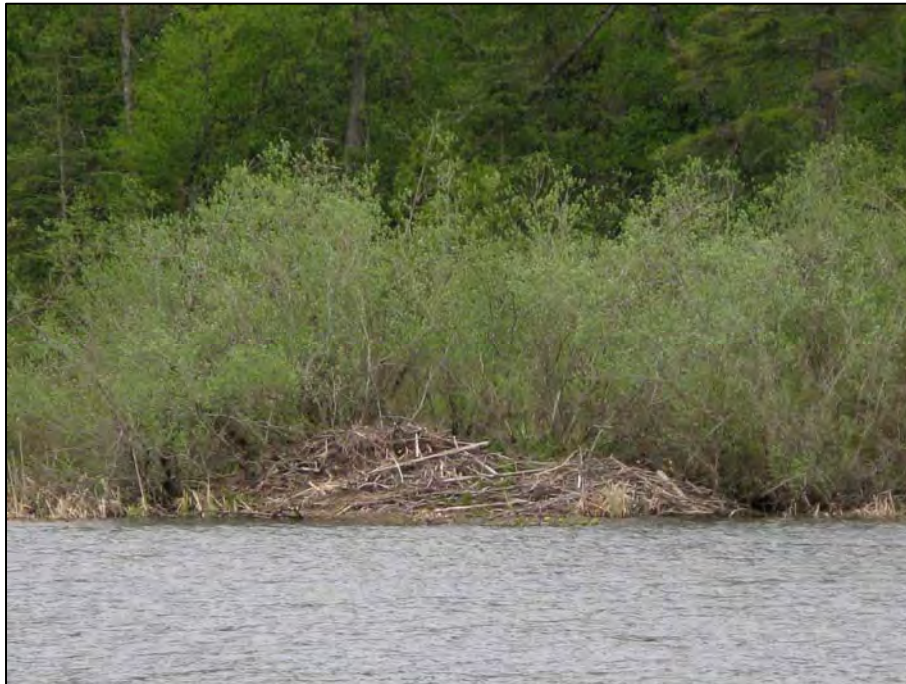
Photo 21. Beaver lodge at edge of wetland on southwest shore of Grafton Lake. This is understood to be the second of three lodges recorded to date. 13-May-09

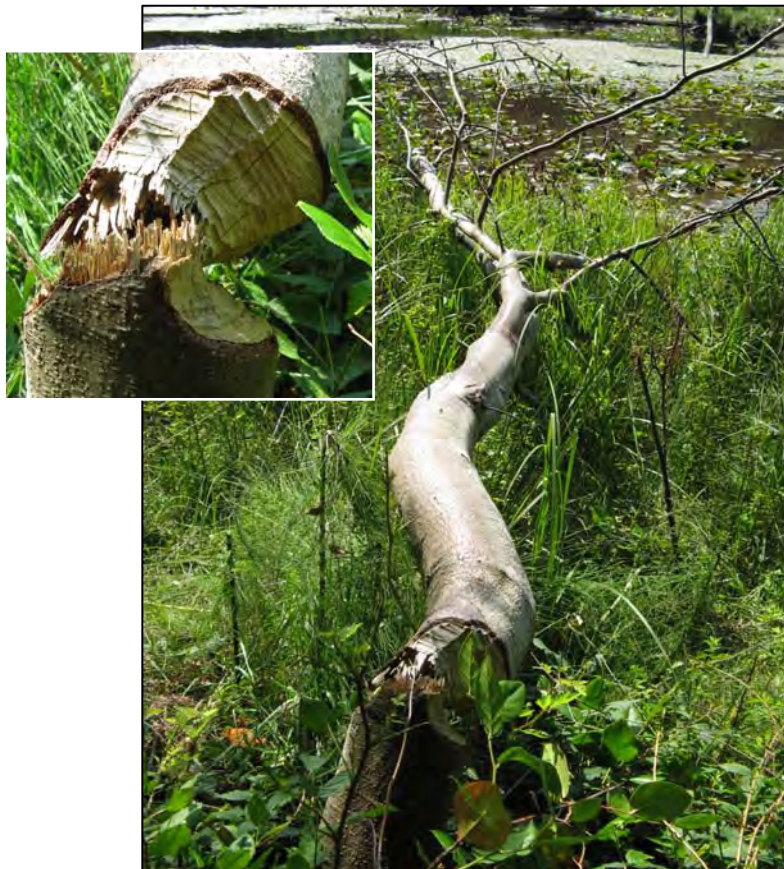
Photo 22. Red alder tree felled by a beaver on the southeast side of Grafton Lake. Tree diameter at cut is approximately 20 cm. 19-May-09

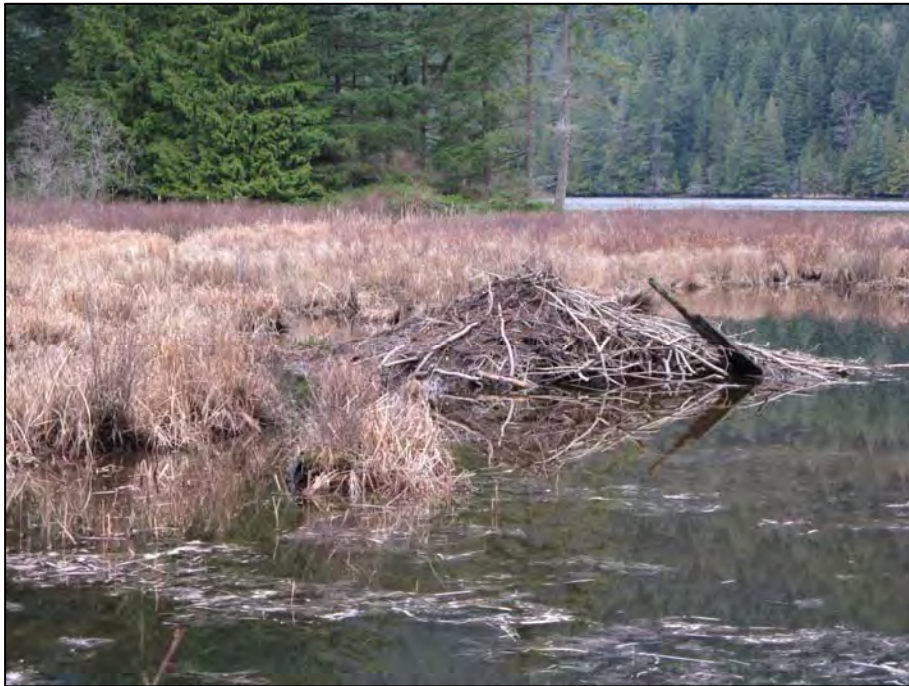
Photo 23. Newest beaver lodge at east end of Grafton Lake, viewed from outlet dam. This lodge was built during late 2009. 3-Feb-10

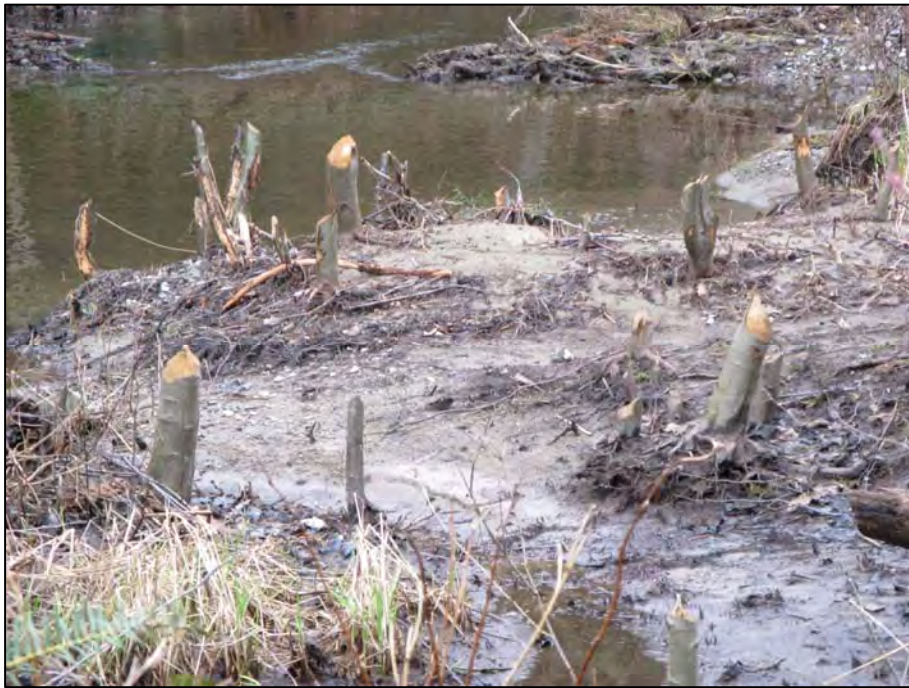
Photo 24. Stumps of red alder trees and smaller shrubs cut by beaver beside terminal Creek immediately downstream of the Grafton lake outlet dam. 3-Feb-10

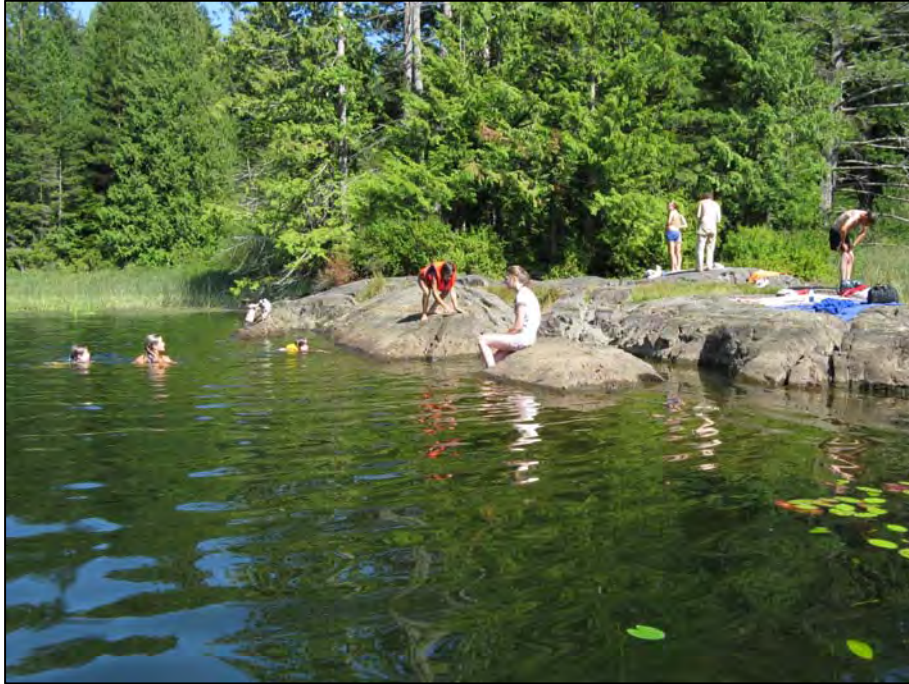
Photo 27. Contact recreation in Grafton Lake reservoir at rocky point. Bacteriological analysis of water sampled at this location confirmed the presence of human fecal contamination. 18-Jul-08
